Residential Inspection Report

1234 Sample Report Dr, Eastern Shore, MD DE VA 12345

Date of Inspection: 11/1/2019 Time: 9:00 am

Manufactured Home Sample Report

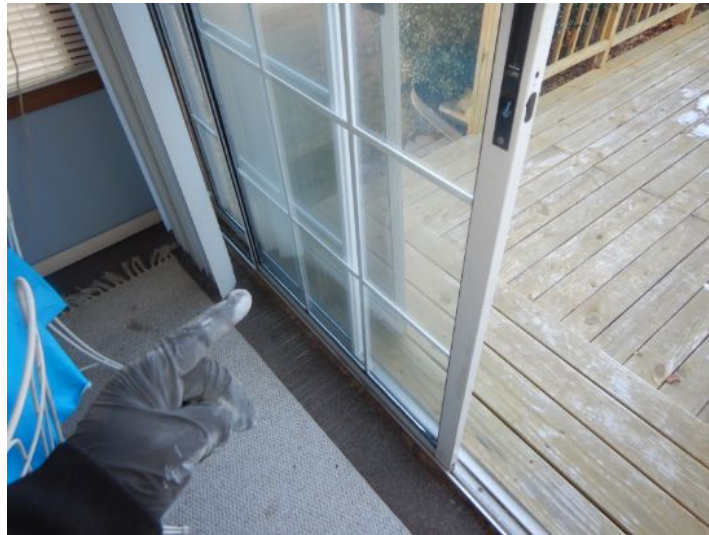
Page 13 Item: 5	Exterior Doors	<ul style="list-style-type: none">• Sliding glass door does not open/close properly. Its takes a lot of effort to slide. I suggest further evaluation by a licensed contractor for repair or replacement as needed.• Cloudiness / condensation observed at the rear glass slider . Left un repaired, over time moisture damage could occur to surrounding areas. I suggest having further evaluation by a licensed window specialist for repair or replacement as needed.
-----------------	----------------	--

Slider door does not open/close properly

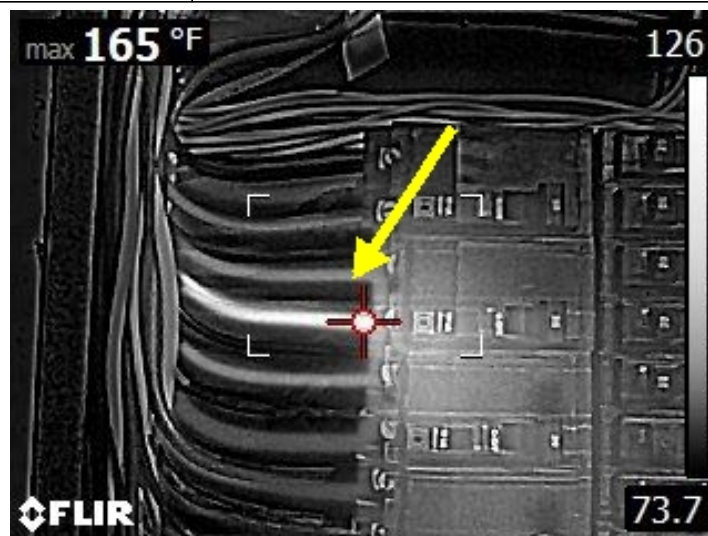
Page 29 Item: 6	Sub Panel(s)	<ul style="list-style-type: none">• An irregularly hot spot observed in the panel box with an IR camera. I suggest further evaluation by a licensed electrician for repair or replacement as needed.
-----------------	--------------	--

An irregularly hot spot observed in the panel box with a FLIR IR camera.

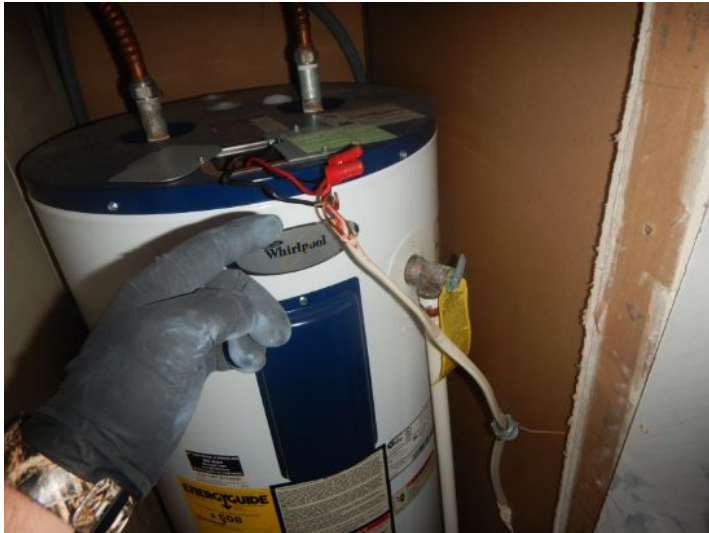
Page 30 Item: 9	Wiring Methods	<ul style="list-style-type: none">• Spliced wire(s) that are not in a junction box observed at the top of the water heater. I suggest further evaluation by a licensed electrician for repair or replacement as needed.• Junction box(s) are missing covers in the crawlspace under the addition at multiple locations and in the shed. I suggest further evaluation by a licensed electrician for repair or replacement as needed.
-----------------	----------------	--

Spliced wire(s) that are not in a junction box

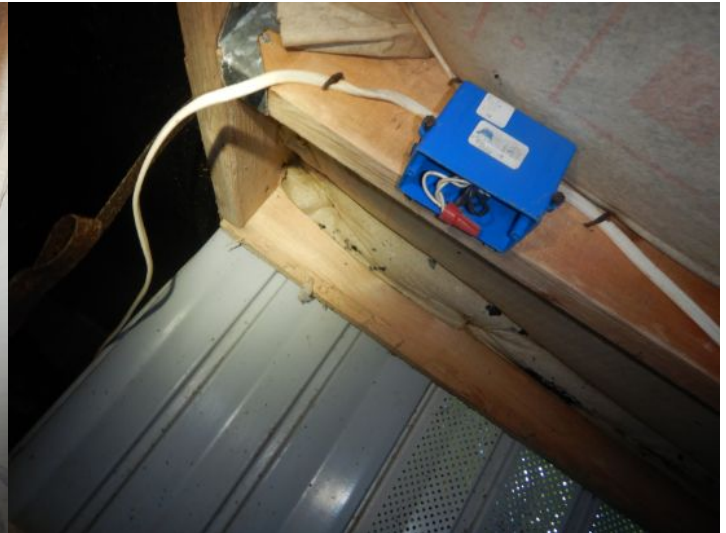
Junction box(s) are missing covers

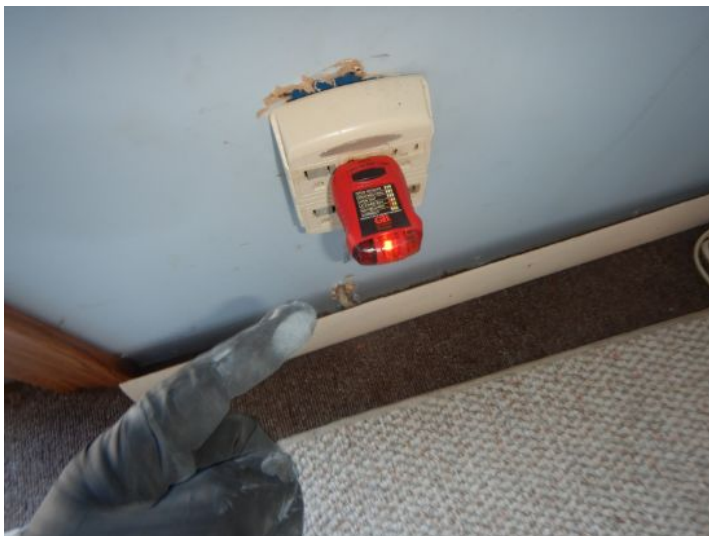
Outlet with an open ground observed

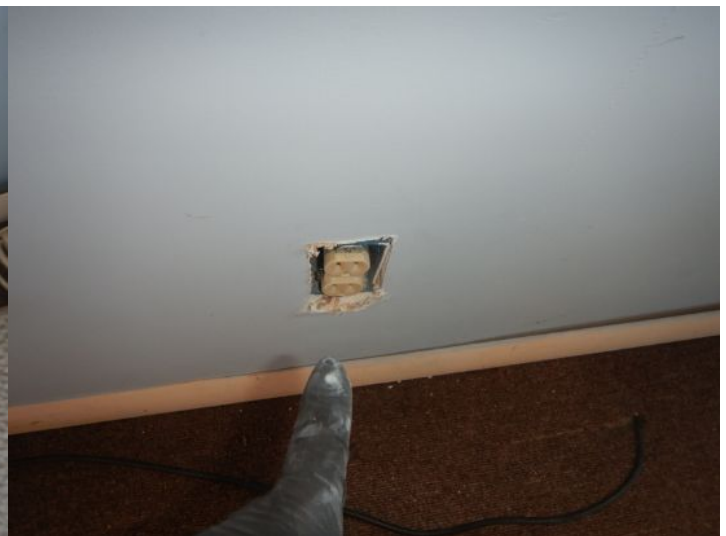
Page 30 Item: 10	Lighting, Fixtures, Switches, Outlets	<ul style="list-style-type: none">• Missing cover plates observed at one addition outlet and one shed outlet. I suggest further evaluation by a licensed electrician for repair or replacement as needed.• Outlet with an open ground observed at the rear wall of the addition. Problem outlet was marked with blue tape. I recommend further evaluation by a licensed electrician for repair or replacement as needed.
------------------	---------------------------------------	---

Missing cover plates observed

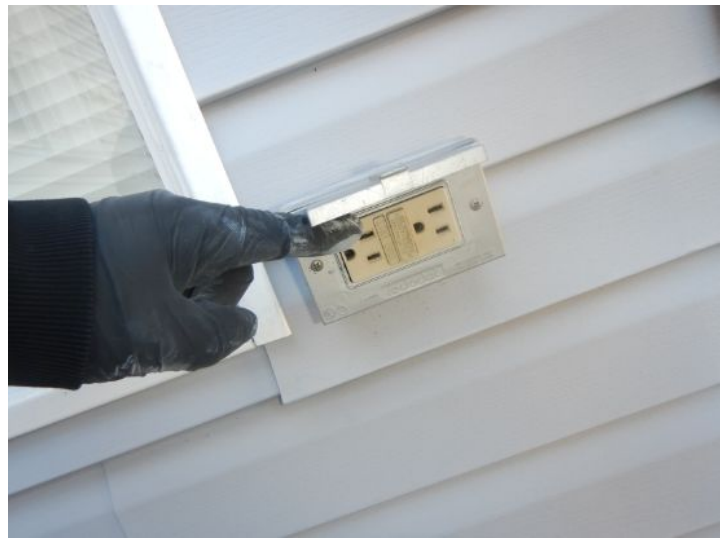
Page 31 Item: 11	GFCI	<ul style="list-style-type: none">• SFC(s) did not work properly at both exterior outlets. I suggest further evaluation by a licensed electrical contractor for repair or replacement as needed.
------------------	------	---

GFCI(s) did not work properly

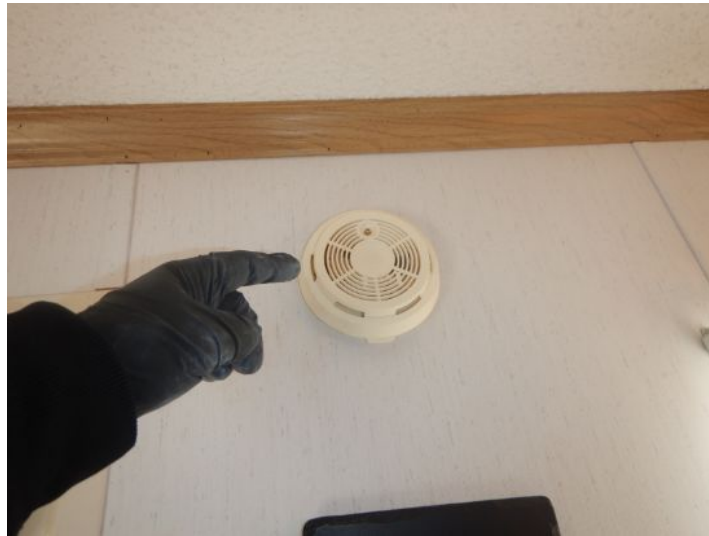
Page 32 Item: 13	Smoke/Heat Detector(s)	<ul style="list-style-type: none">• SAFETY CONCERN: The smoke alarm(s) did not operate when tested. They also appear to be older than 10 years (they should not be). I recommend further evaluation by a qualified licensed contractor for repairs, improvements or replacement as needed.
------------------	------------------------	--

The smoke alarm(s) did not operate

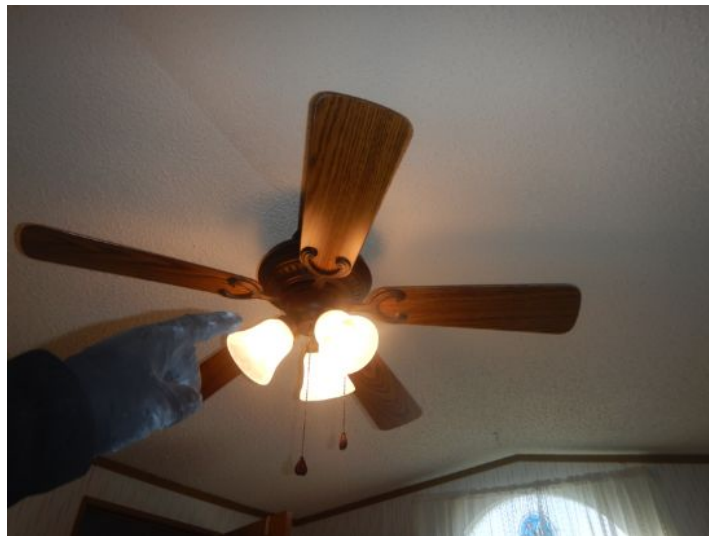
The ceiling fan did not operate properly

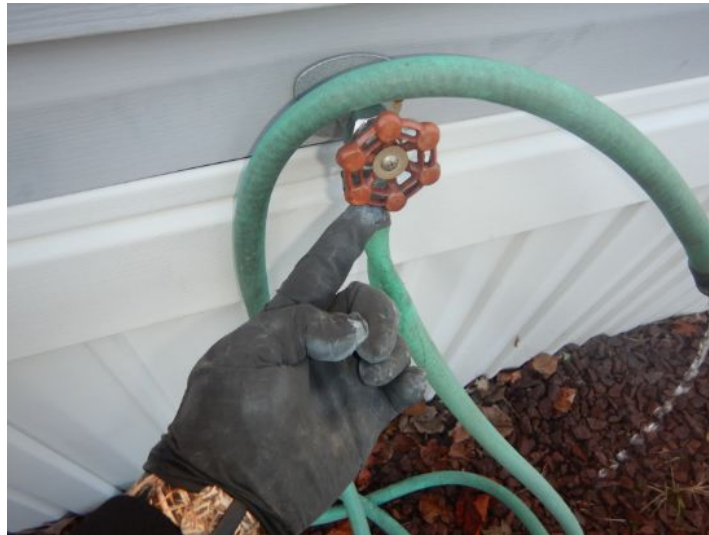
- Exterior hose bib leaks while running. I suggest further evaluation by a licensed plumber for repair or replacement as needed.

Exterior hose bib leaks

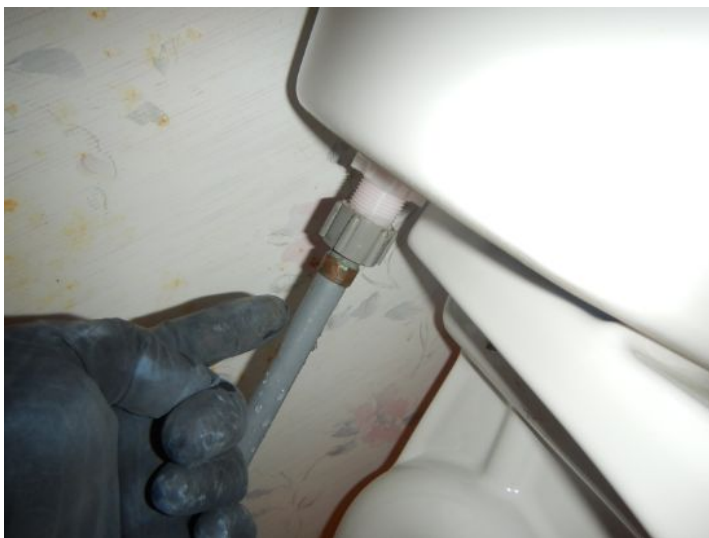
- A leak was observed at the supply line to the rear bathroom toilet. I suggest further evaluation by a licensed plumbing contractor for repair or replacement as needed.
- The water supply pipes are mostly Polybutylene plastic (PB). This type of supply pipe has experienced a higher than normal failure rate associated with leaks where the pipes are joined together, and from chlorine related issues. I recommend you goggle or otherwise research problems associated with this type of plumbing system (<https://www.nachi.org/pb.htm>) and rely on the evaluation and advice of a licensed plumbing contractor for repair or replacement as needed or desired.

A leak was observed

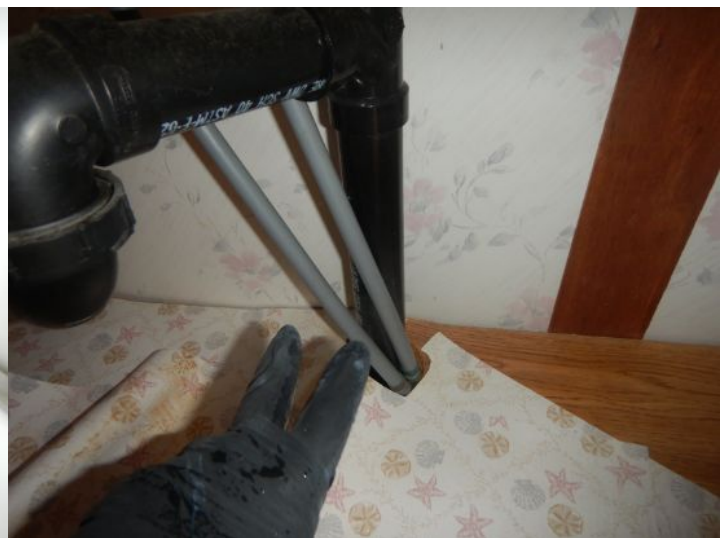
The water supply pipes are mostly Polybutylene plastic (PB)

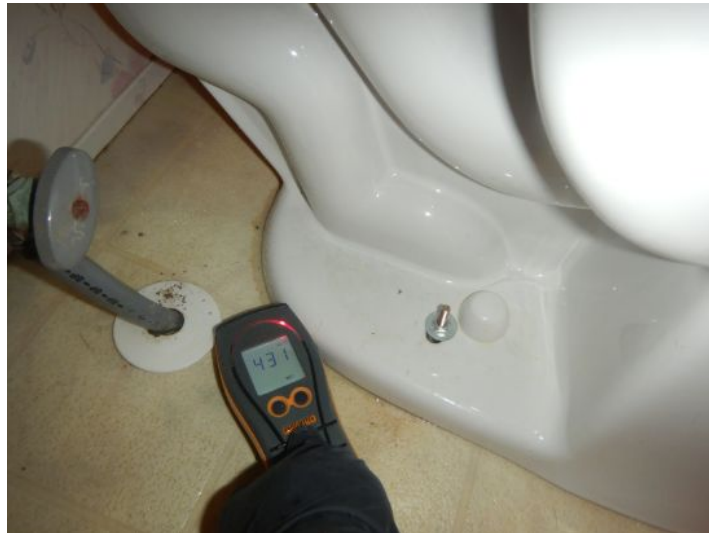
Page 39 Item: 3	Toilet(s)	<ul style="list-style-type: none">Elevated moisture detected around the toilet in the master bathroom. This may be related to the plumbing leak in this area or the wax ring leaking. I suggest further evaluation by a licensed plumber for repair or replacement as preventative maintenance.
-----------------	-----------	---

Elevated moisture detected around the toilet in the master bathroom

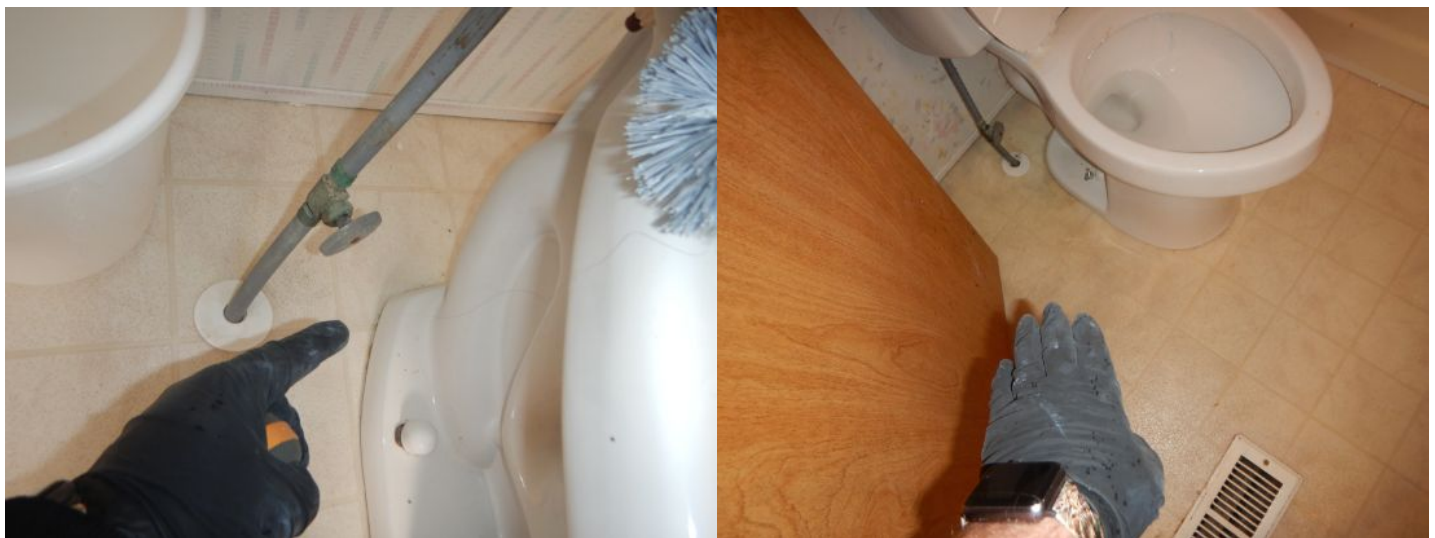
Page 41 Item: 9	Flooring	<ul style="list-style-type: none">Soft, and or spongy flooring observed or felt around both toilets. Staining was observed at scattered locations in the bathrooms and into the hall way by the rear bathroom. No moisture was detected in the flooring at the stained areas but the areas around the toilets have elevated moisture readings. I suggest further evaluation by a licensed contractor of the flooring and sub flooring for repairs or replacements as needed.
-----------------	----------	--

Soft, and or spongy flooring observed or felt

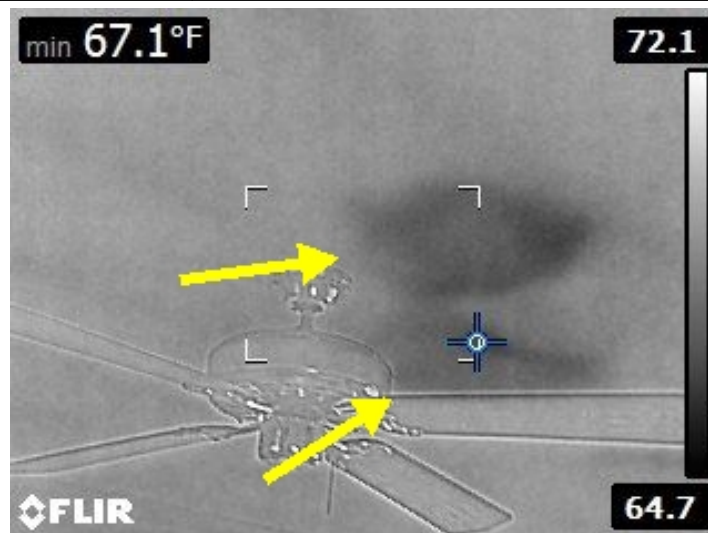
Page 43 Item: 1	Wall and Ceiling Finishes	<ul style="list-style-type: none">Irregular IR scans and moisture detected at the ceiling above the living room fan. Some staining or damage was visible in this area. I suggest further evaluation by a qualified licensed contractor to determine the source of the moisture and for repairs or replacement as needed to prevent ongoing moisture issues. Make repairs and repaint as needed. Have an environmental contractor remediate if and as needed.
-----------------	---------------------------	--

Moisture was located with a FLIR IR camera and confirmed with a Protometer moisture meter.

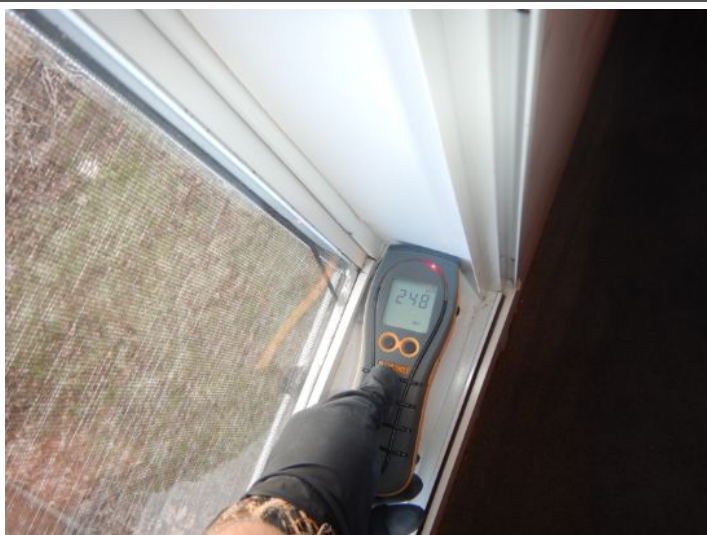
Page 47 Item: 4	Windows	<ul style="list-style-type: none">Moisture damaged observed and elevated moisture detected at the inside sill of the north side master bedroom window. I suggest further evaluation of the window, exterior cladding, flashing, and wall structure by a licensed contractor for repair, sealing or replacement as needed. Have further evaluation by a licensed environmental contractor for remediation if and as needed. I was unable to determine if any hidden damage has occurred.
-----------------	---------	---

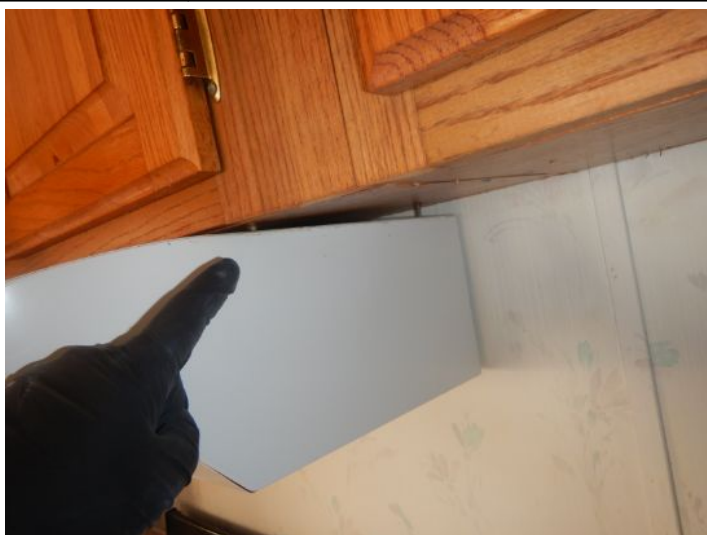
Page 47 Item: 4	Kitchen Hood/Exhaust Fan	• Exhaust fan is loose and is pulling away from the cabinet. Have a licensed contractor make repairs or replacements as needed.
-----------------	--------------------------	---

Exhaust fan is loose and is pulling away from the cabinet.

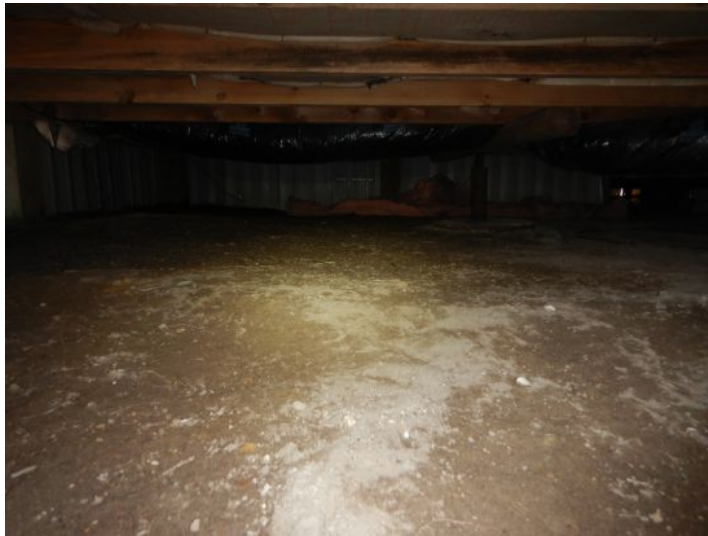
Page 52 Item: 4	Under Floor Crawlspace(s)	• There is no vapor barrier installed in the crawl space under the addition. I suggest having a licensed contractor install one that covers one hundred percent of the crawl space, and bends up the foundation walls a few inches.
-----------------	---------------------------	---

There is no vapor barrier installed

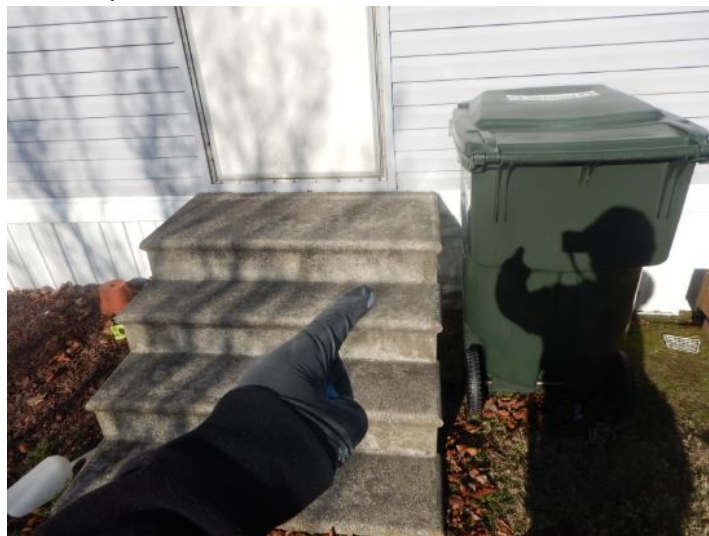
- Maintenance: Some settlement appears to have occurred at the south side steps. I suggest consulting a qualified licensed contractor for repairs as needed and feasible.

Maintenance: Some settlement appears to have occurred

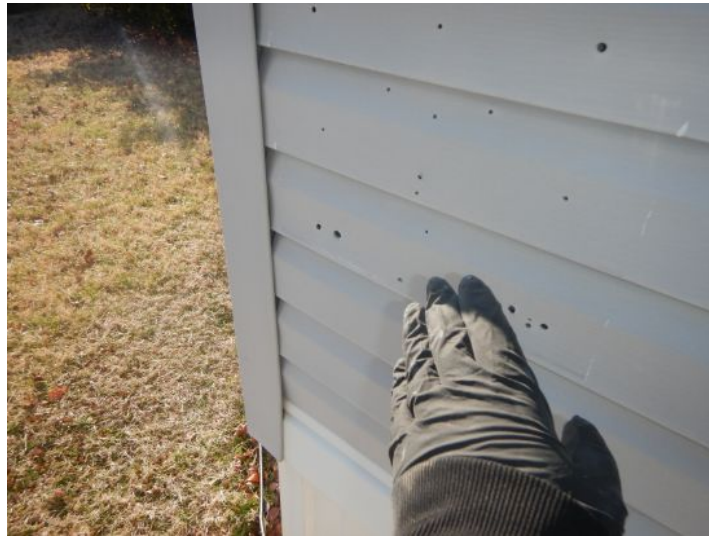
Maintenance: Some cracks and damaged areas observed

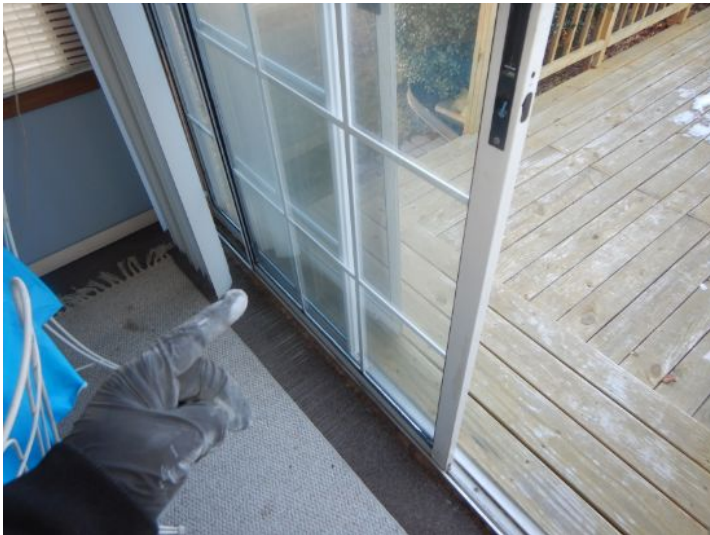
- Maintenance: Shut the front door with caution as your fingers can get pinch due to the trim that was installed. I suggest removal of this trim as needed.
- Sliding glass door does not open/close properly. Its takes a lot of effort to slide. I suggest further evaluation by a licensed contractor for repair or replacement as needed.
- Cloudiness / condensation observed at the rear glass slider . Left un repaired, over time moisture damage could occur to surrounding areas. I suggest having further evaluation by a licensed window specialist for repair or replacement as needed.

Slider door does not open/close properly

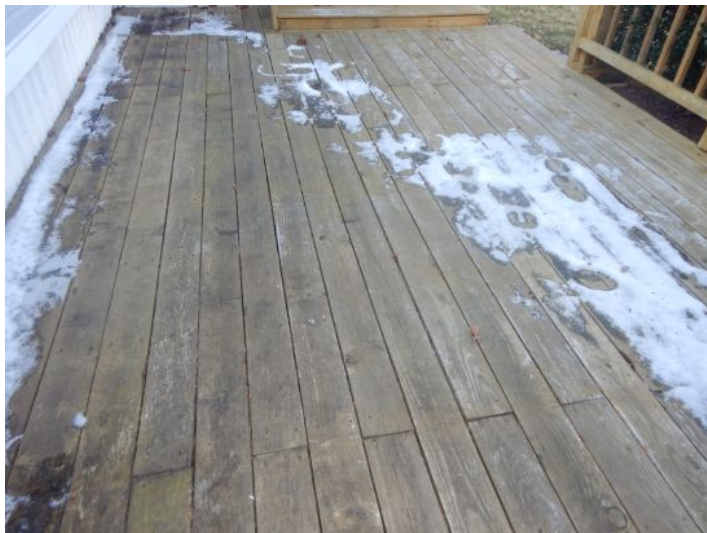
- FYI: The underside of deck was not visible. These areas were not inspected.
- Maintenance: Weathered wood surfaces observed at the deck. I suggest monitoring and maintaining your deck as needed. Make repairs or replace decking as desired or when needed.

Maintenance: Weathered wood surfaces observed

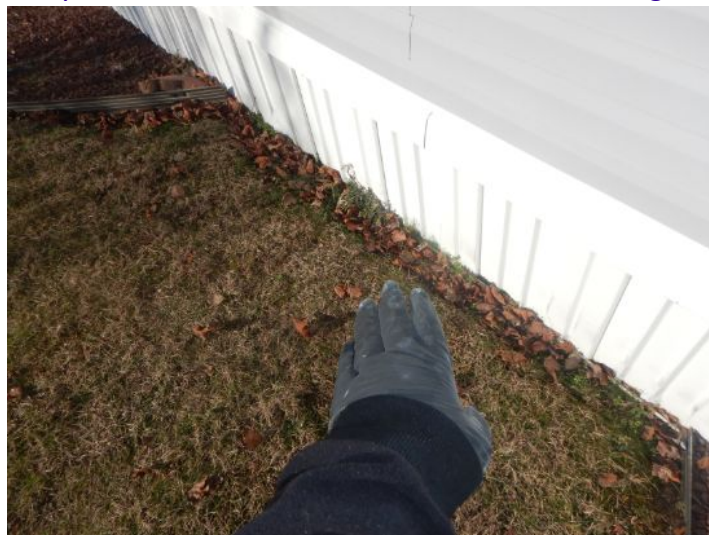
Maintenance: There are several low spots along the foundation

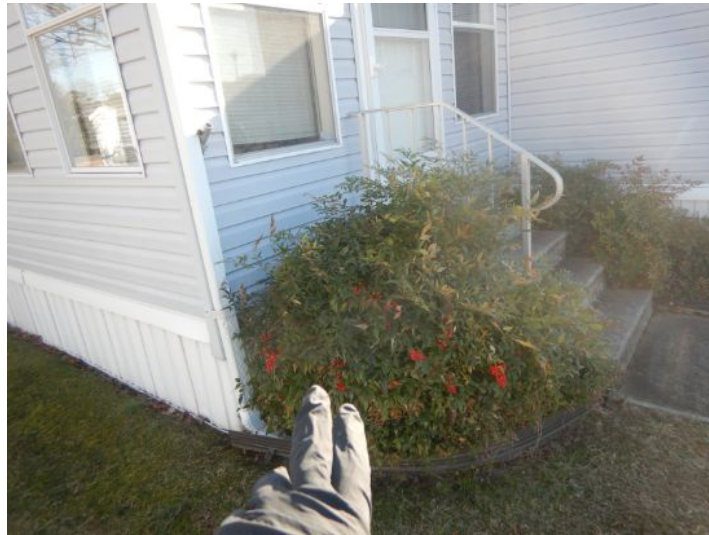
Maintenance: Overgrown vegetation in contact with structure

- FYI: It's recommended that tree branches do not overhang the roof and that all vegetation is kept well pruned and not permitted to grow up against any part of the structure.
- Maintenance: Overgrown vegetation in contact with structure. I suggest trimming, pruning or removing as needed at all problem locations.

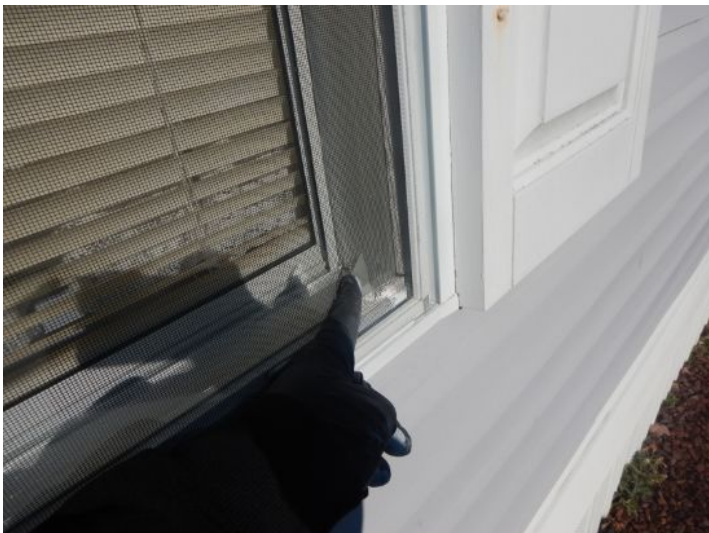
Maintenance: Several screens were observed with holes and damages

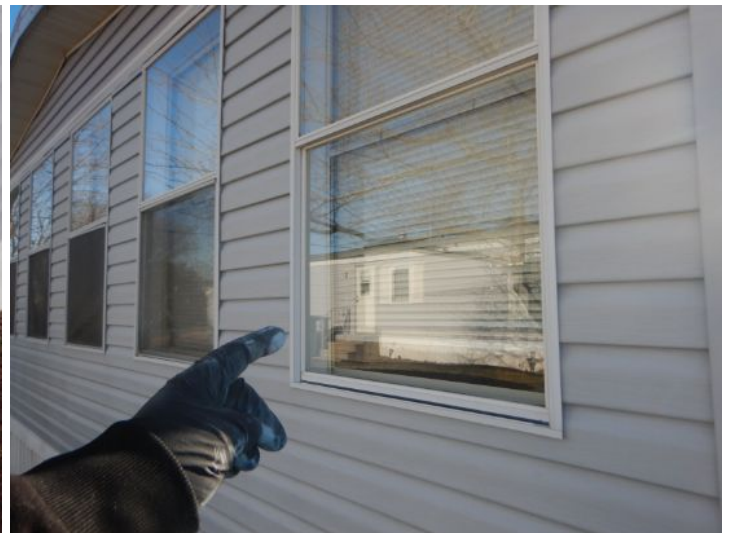
- Maintenance: Missing screens observed at several of the homes windows. I suggest installing screens as they help prevent damage to, and may increase the life span, of the windows and window frames. Consult with the seller to see if they are in storage and in good condition. Replace or have installed as needed or as desired.
- Maintenance: Several screens were observed with holes and damages. Have a contractor repair or replace as needed.

Maintenance: Missing screens observed

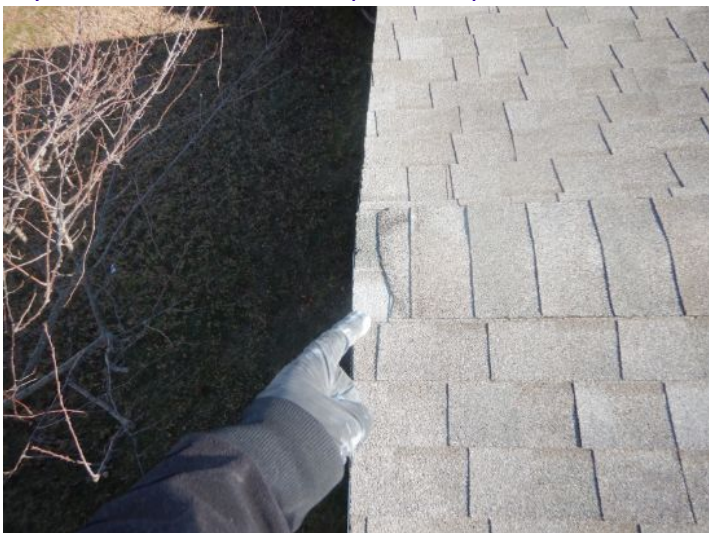
Maintenance: Missing/damaged tab observed

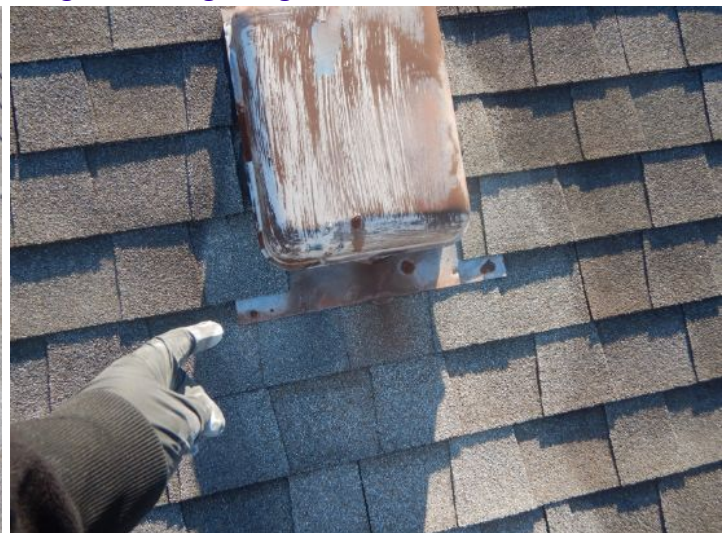
Maintenance: Exposed nail heads observed

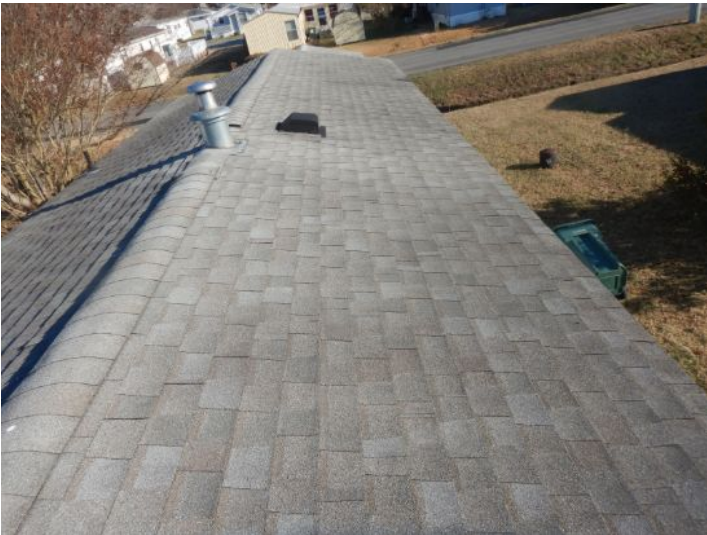
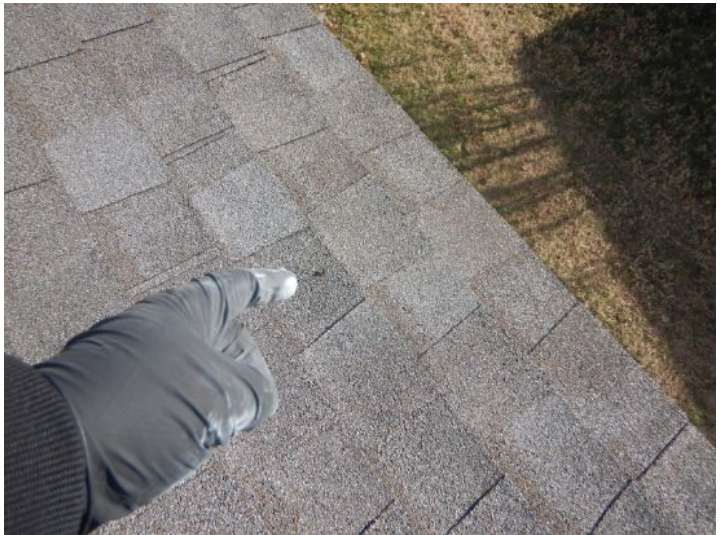
Maintenance: Nail pop(s) observed

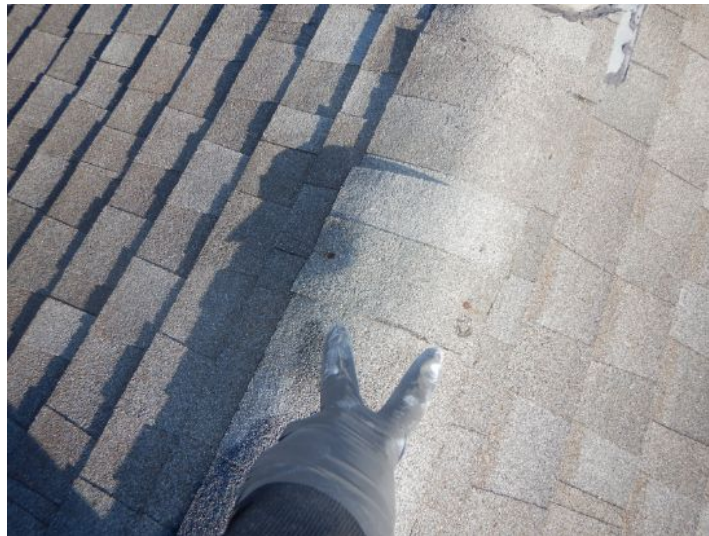
Maintenance: Exposed nail heads observed

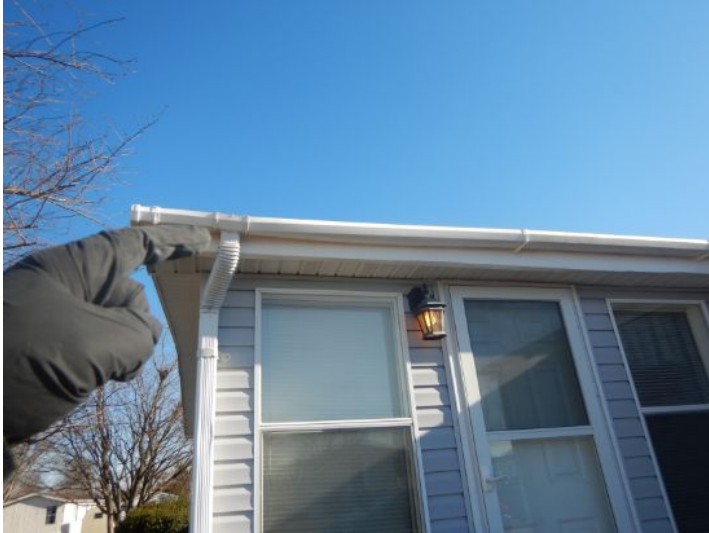
Maintenance: Damaged gutters observed

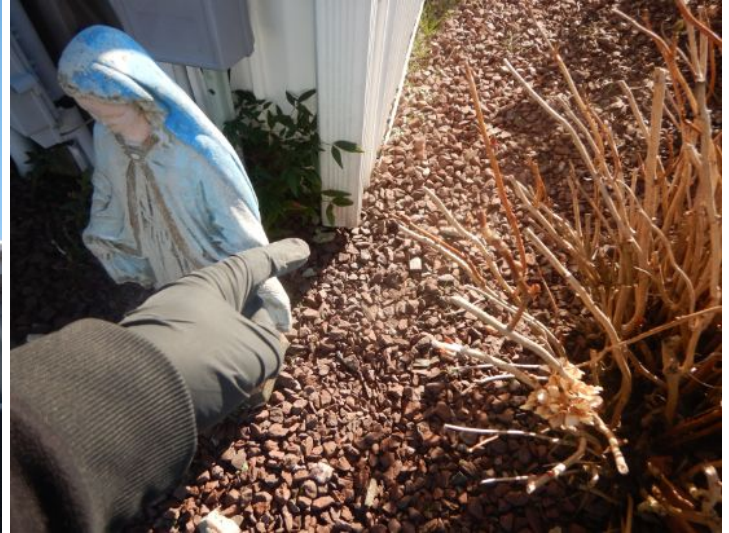
Maintenance: Missing downspout elbow observed

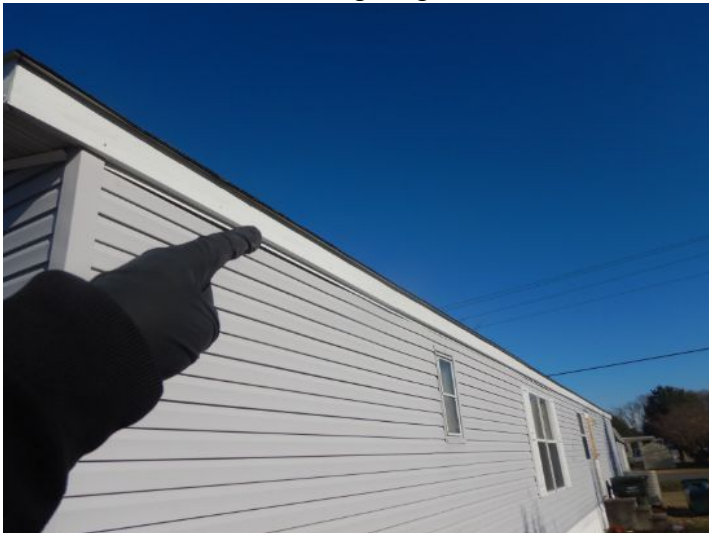
Maintenance: There are no gutters and down spouts

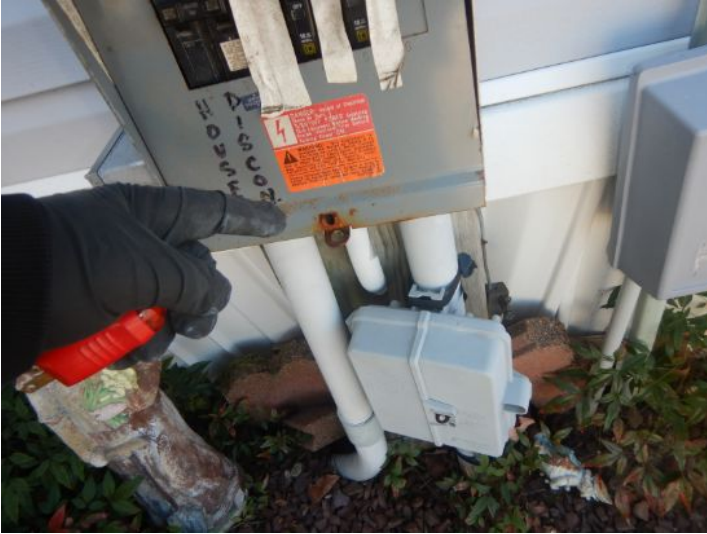
Maintenance: Screw(s) are missing

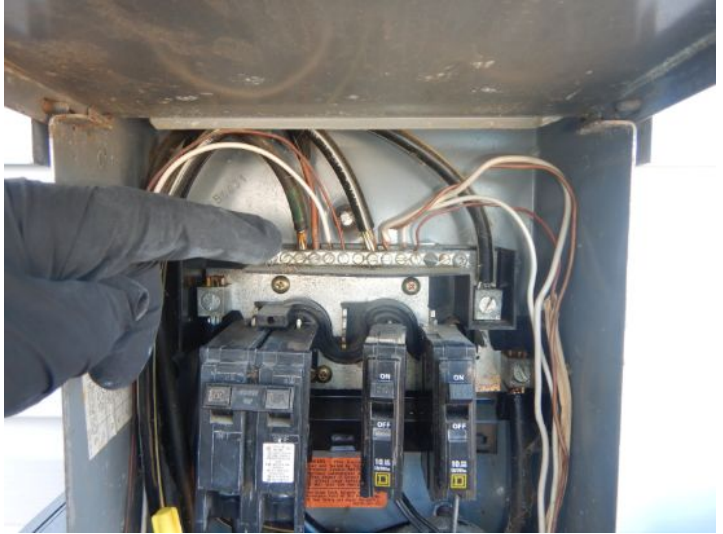
Maintenance: More than one wire is attached at the same terminal space(s)

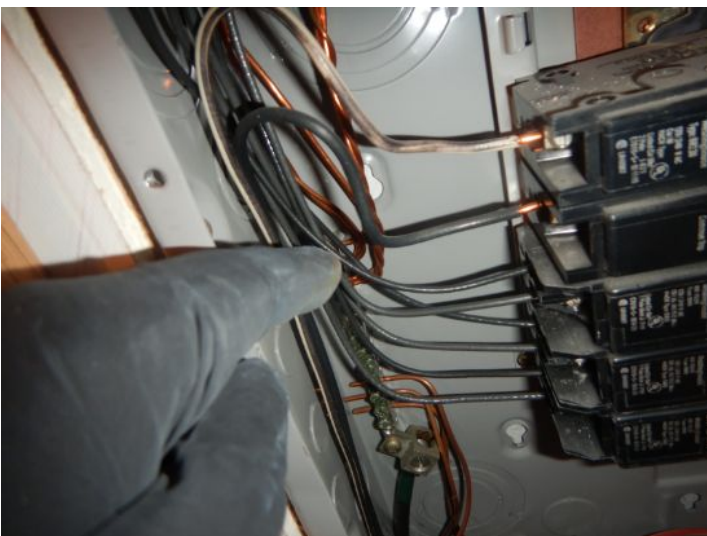
- Maintenance: More than one wire is attached at the same terminal space(s) on the buss bar(s) in the panel box. This is something that we commonly see. However, this is not a recommended practice. Have further evaluation by a licensed electrician for repairs or improvements as needed or desired.
- An irregularly hot spot observed in the panel box with an IR camera. I suggest further evaluation by a licensed electrician for repair or replacement as needed.

Maintenance: More than one wire is attached at the same terminal space(s)

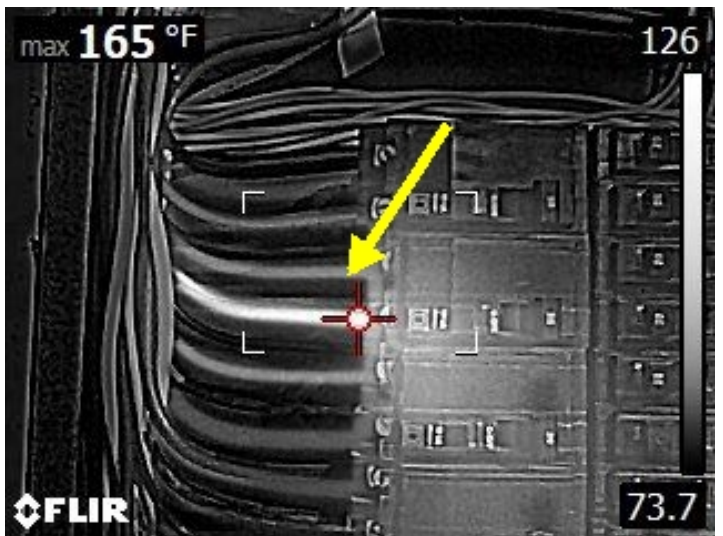
An irregularly hot spot observed in the panel box with a FLIR IR camera.

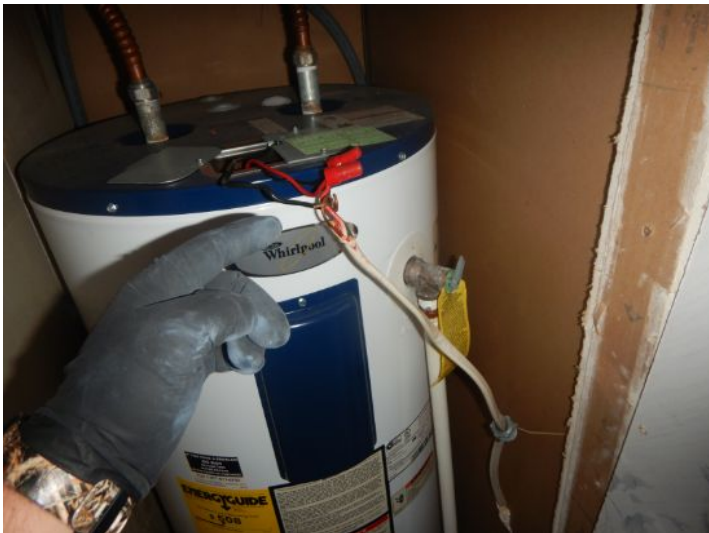
- Spliced wire(s) that are not in a junction box observed at the top of the water heater. I suggest further evaluation by a licensed electrician for repair or replacement as needed.
- Junction box(s) are missing covers in the crawlspace under the addition at multiple locations and in the shed. I suggest further evaluation by a licensed electrician for repair or replacement as needed.

Spliced wire(s) that are not in a junction box

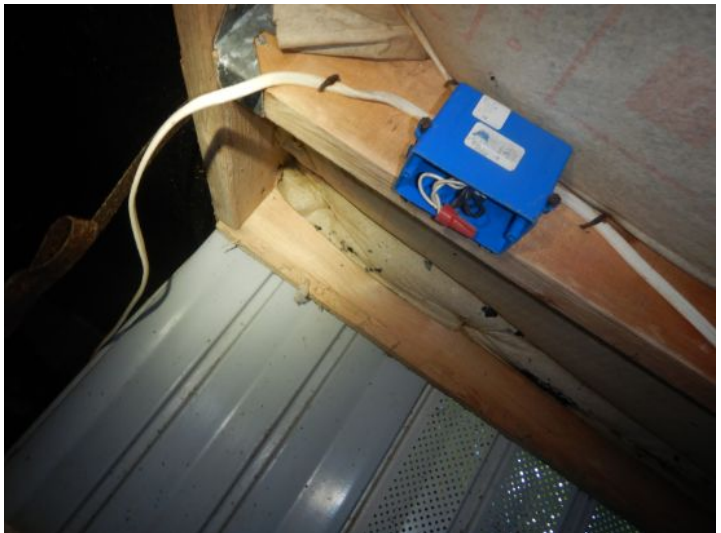
Junction box(s) are missing covers

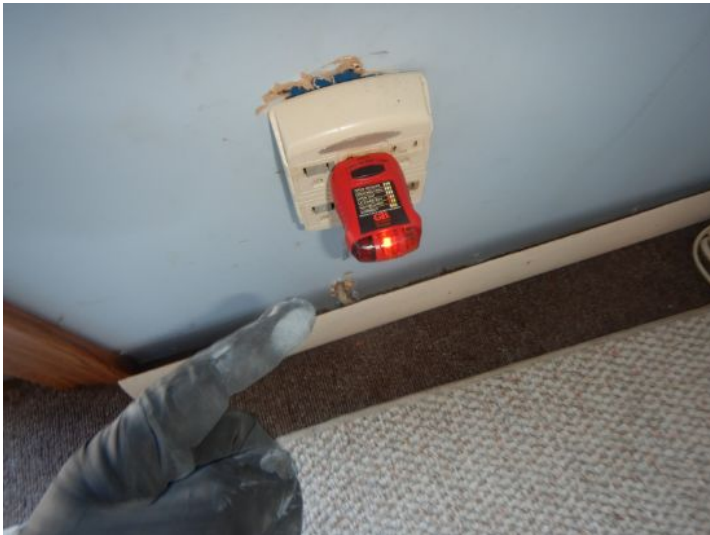
Outlet with an open ground observed

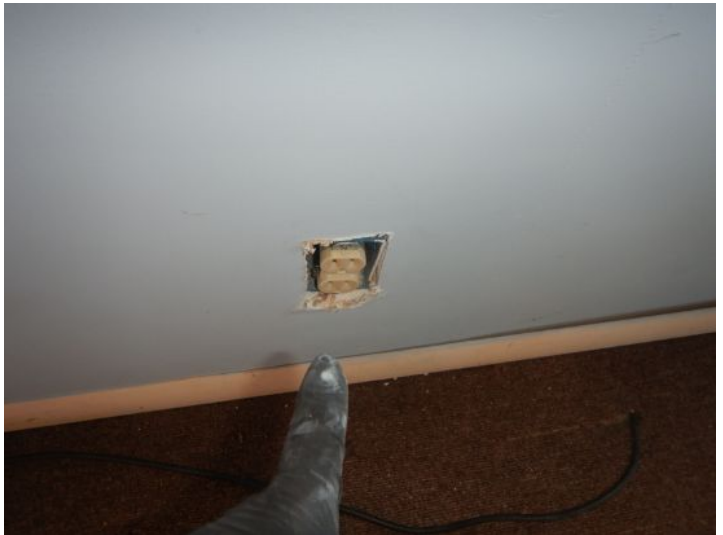
- A representative sampling of outlets, switches and light fixtures were tested.
- Missing cover plates observed at one addition outlet and one shed outlet. I suggest further evaluation by a licensed electrician for repair or replacement as needed.
- Outlet with an open ground observed at the rear wall of the addition. Problem outlet was marked with blue tape. I recommend further evaluation by a licensed electrician for repair or replacement as needed.

Missing cover plates observed

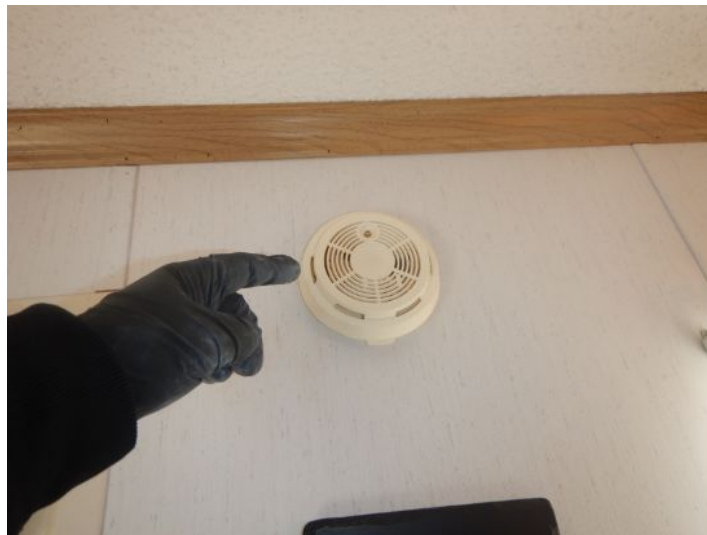
- **SAFETY CONCERN:** The smoke alarm(s) did not operate when tested. They also appear to be older than 10 years (they should not be). I recommend further evaluation by a qualified licensed contractor for repairs, improvements or replacement as needed.

The smoke alarm(s) did not operate

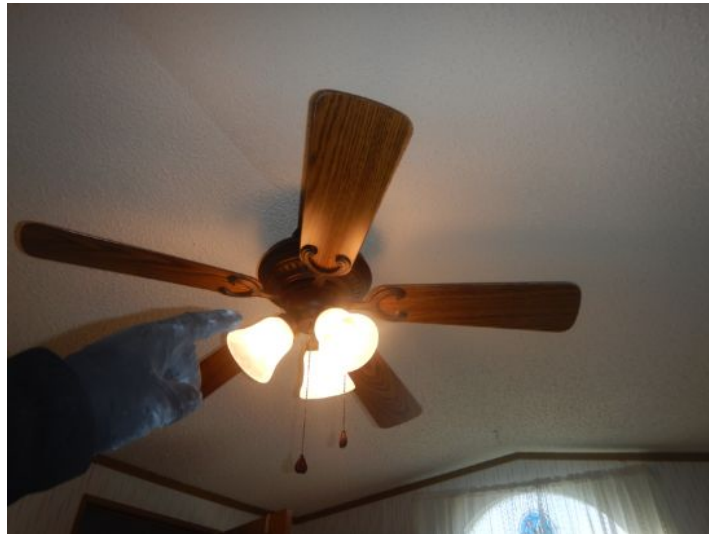
- The ceiling fan did not operate properly in the front bedroom. When turned on it was very slow moving and then as you switch between the speed settings it never increases. Have further evaluation by a licensed electrician for repair or replacement as needed.

The ceiling fan did not operate properly

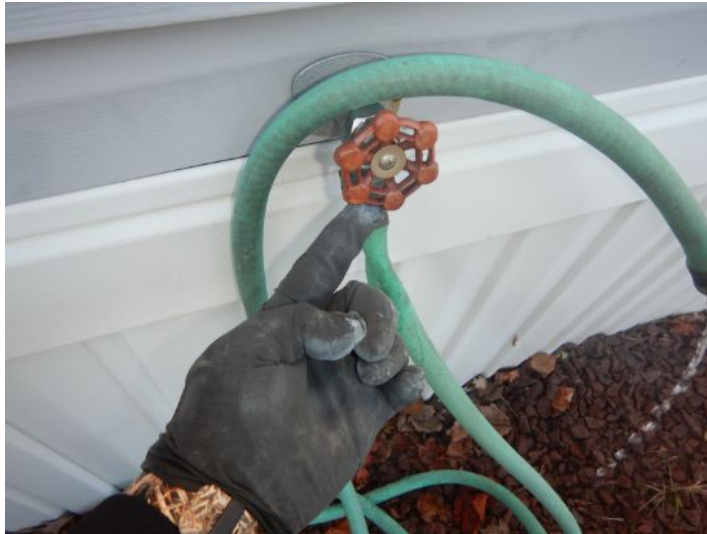
- Maintenance: Install the frost-free type faucet to reduce the risk of a burst/frozen pipe or faucet.
- Exterior hose bib leaks while running. I suggest further evaluation by a licensed plumber for repair or replacement as needed.

Exterior hose bib leaks

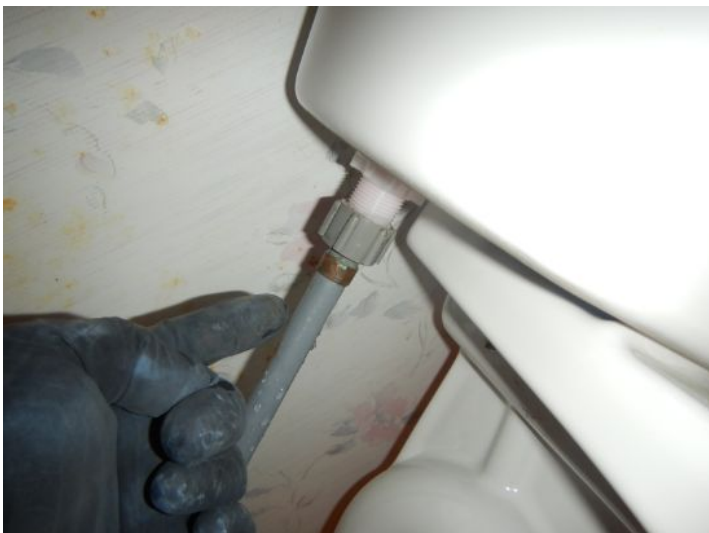
- A leak was observed at the supply line to the rear bathroom toilet. I suggest further evaluation by a licensed plumbing contractor for repair or replacement as needed.
- The water supply pipes are mostly Polybutylene plastic (PB). This type of supply pipe has experienced a higher than normal failure rate associated with leaks where the pipes are joined together, and from chlorine related issues. I recommend you goggle or otherwise research problems associated with this type of plumbing system (<https://www.nachi.org/pb.htm>) and rely on the evaluation and advice of a licensed plumbing contractor for repair or replacement as needed or desired.

A leak was observed

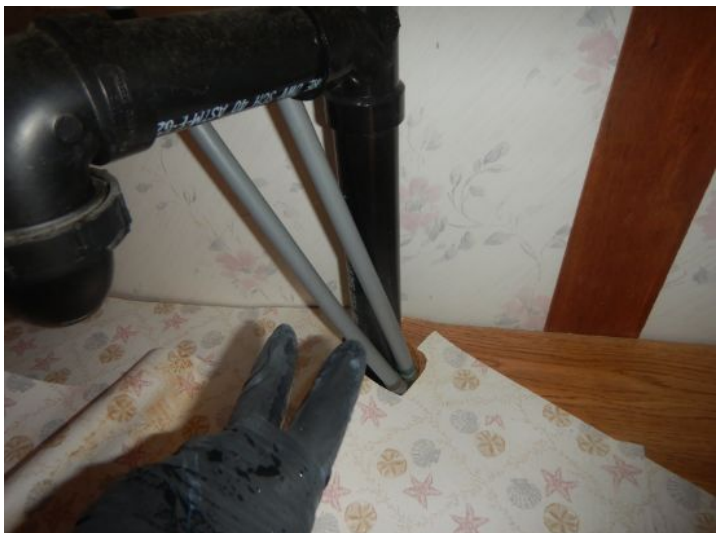
The water supply pipes are mostly Polybutylene plastic (PB)

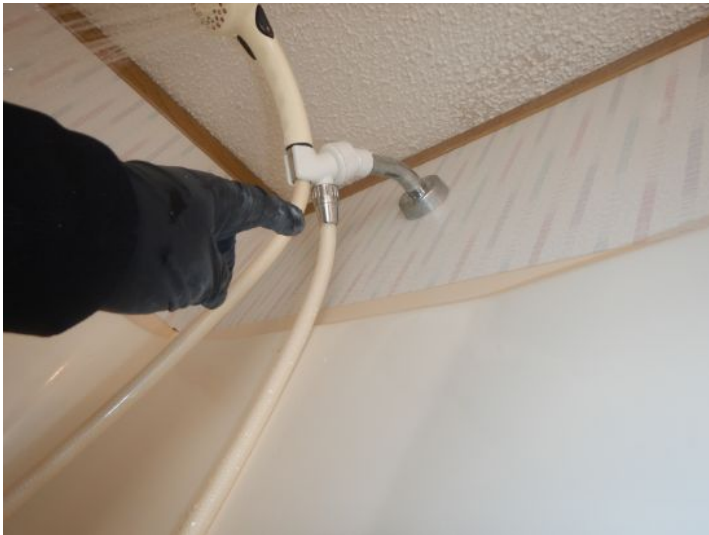
Maintenance: The shower heads are loose

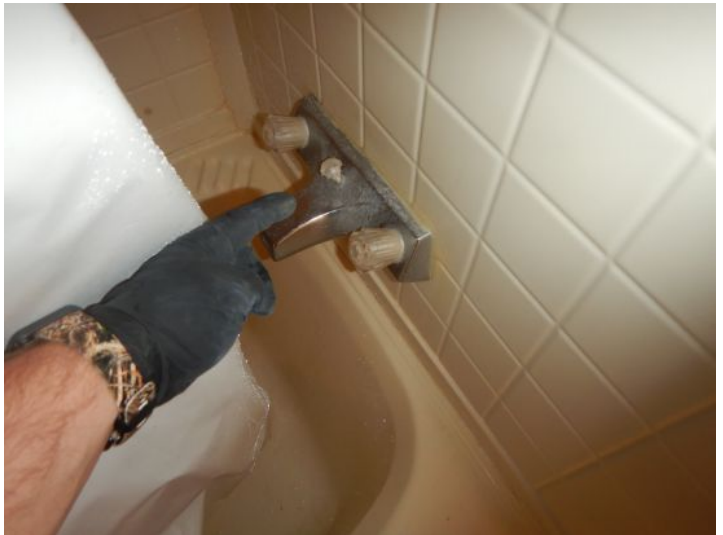
Maintenance: The shower diverter does not operate properly

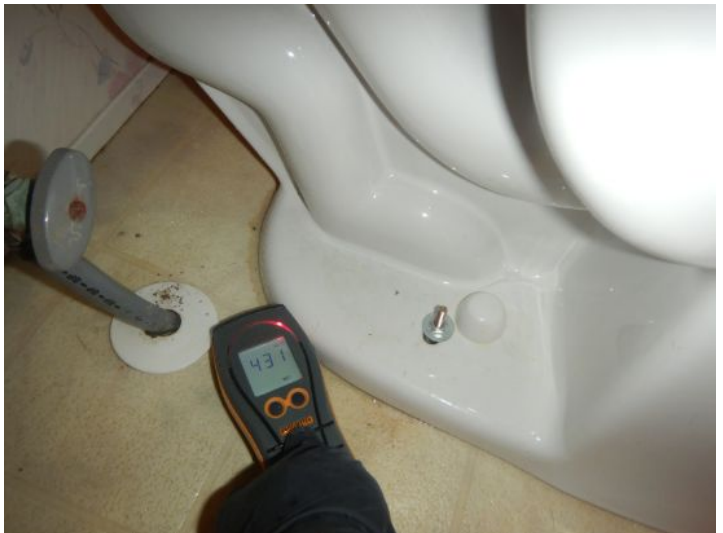
Elevated moisture detected around the toilet in the master bathroom
