Residential Inspection Report

1234 Sample Report Dr, Eastern Shore, MD DE VA 12345

Date of Inspection: 11/1/2019 Time: 9:00 am

Manufactured Home Sample Report

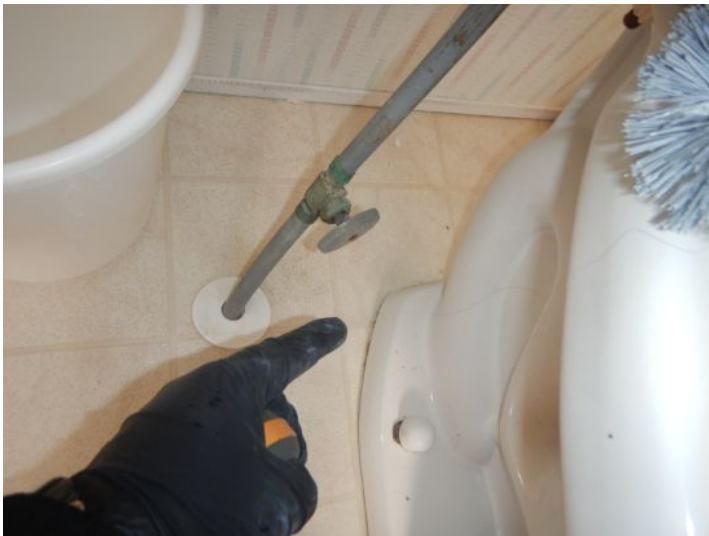
Soft, and or spongy flooring observed or felt

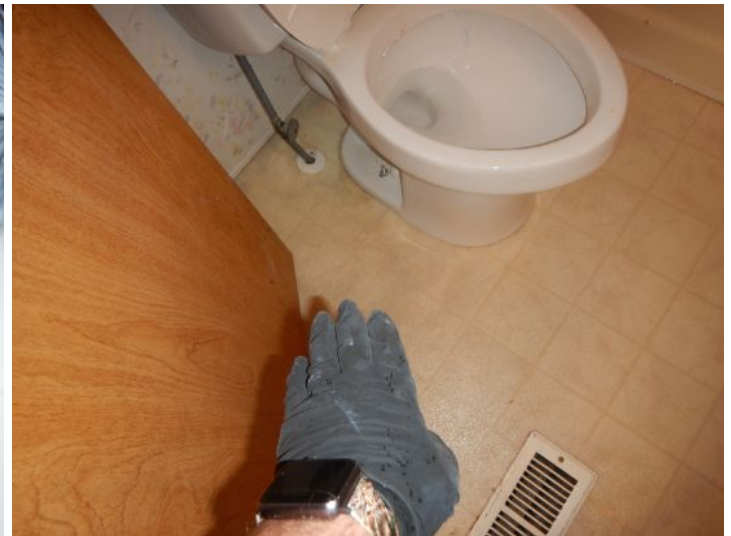
Soft, and or spongy flooring observed or felt

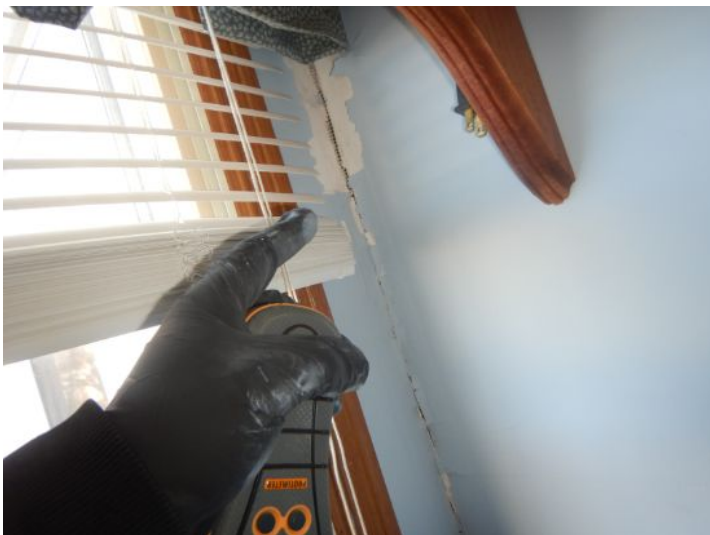
Maintenance: There is a greater than normal amount of cosmetic, common small cracks, and flaws observed

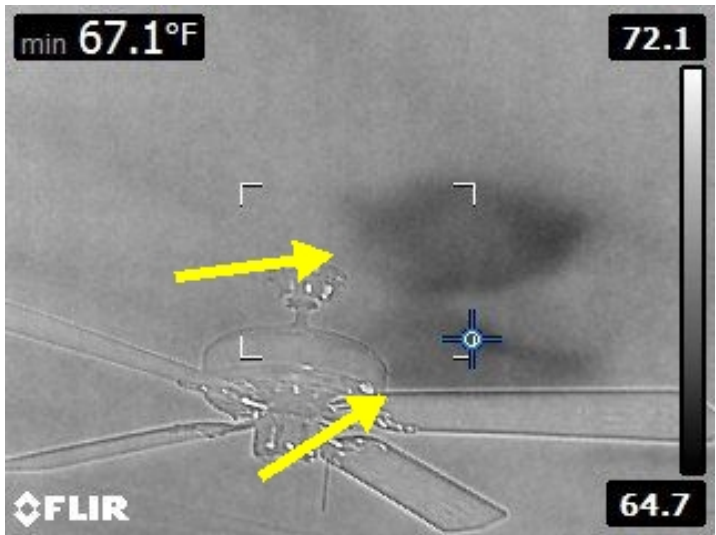
Moisture was located with a FLIR IR camera and confirmed with a Protometer moisture meter.

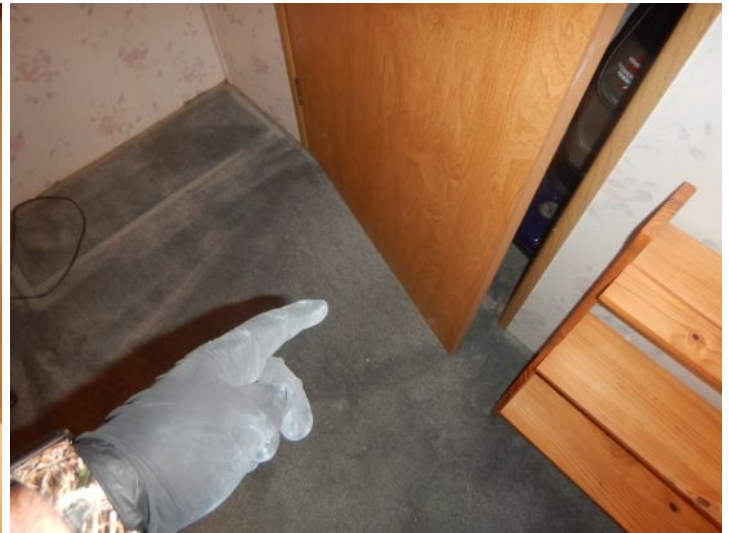
Maintenance: Doors stick or rub

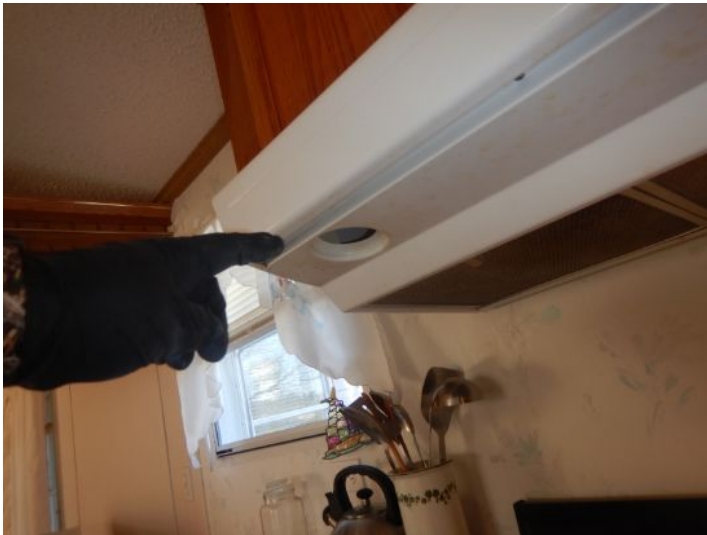
Maintenance: The light did not operate

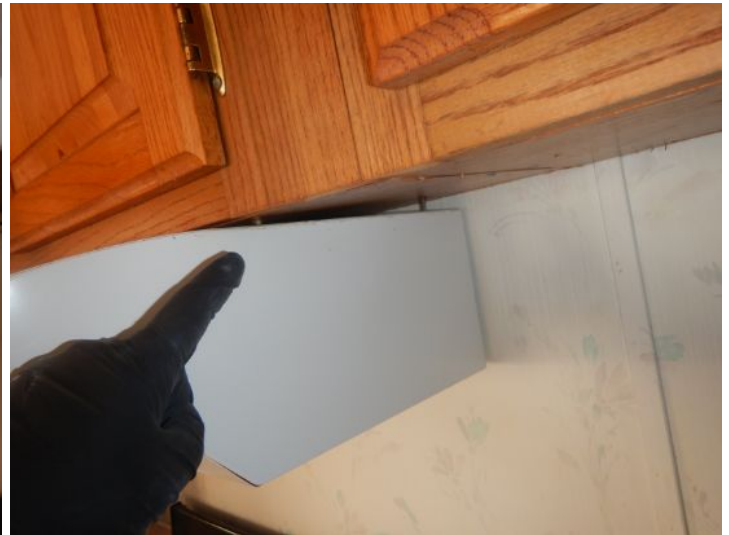
Exhaust fan is loose and is pulling away from the cabinet.

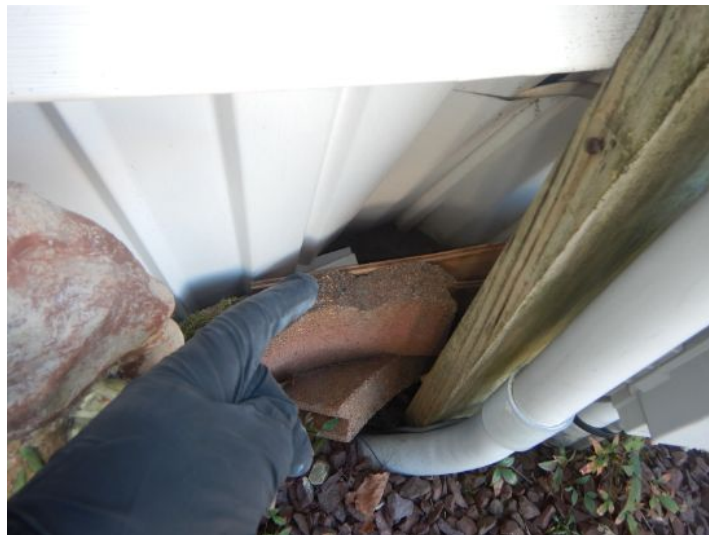
Maintenance: Some cracks and damaged areas observed

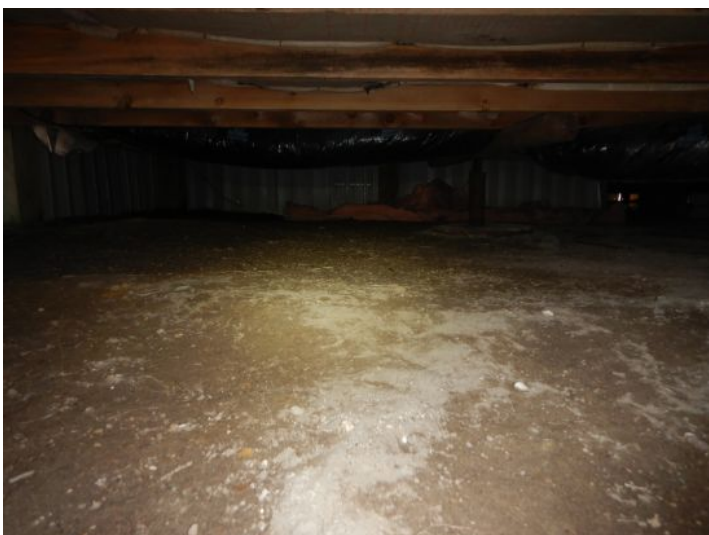
There is no vapor barrier installed

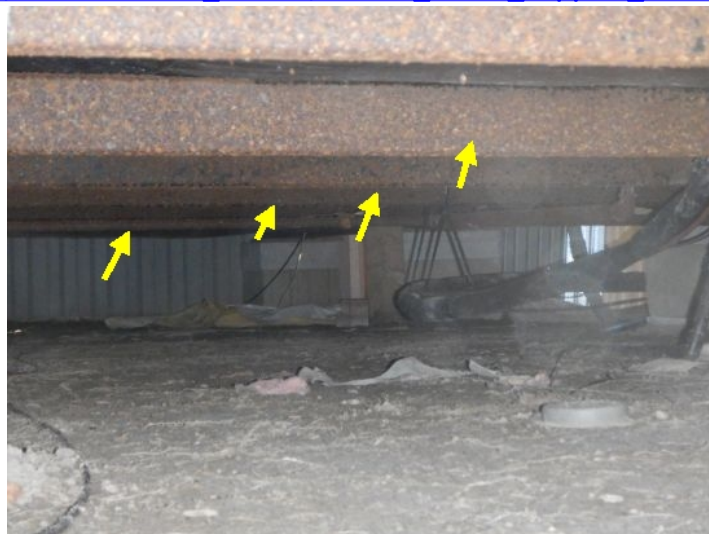
Maintenance: Rust and corrosion observed .

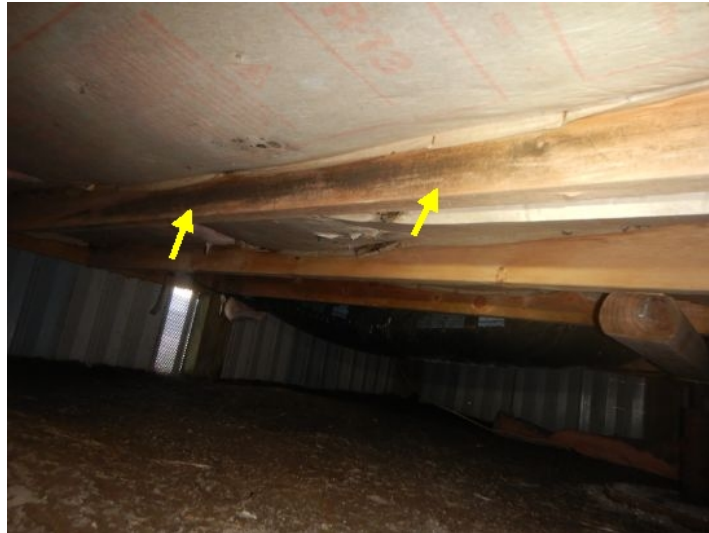
Maintenance: Some staining observed
