# Exterior Cladding Inspection Report

Bay Farm Rd., Long Neck , DE 19966

Date of Inspection: 5/10/2022

Inspector: Jake Raynor

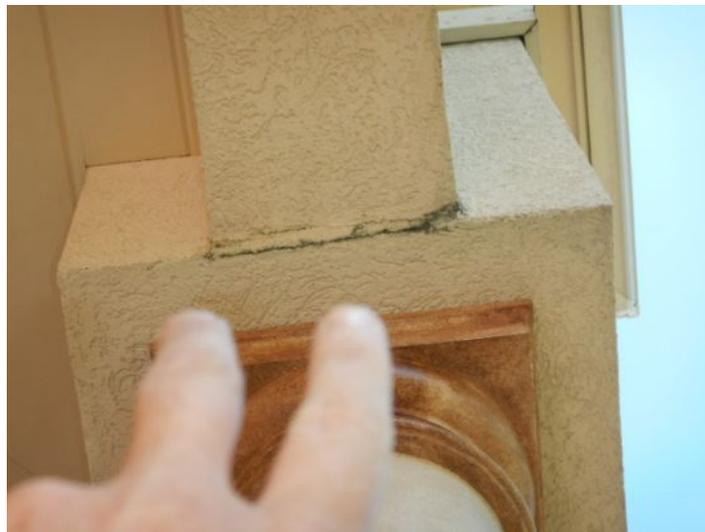
Page 11 Item: 1 | Front of Home

Damages and staining observed at a front column area.

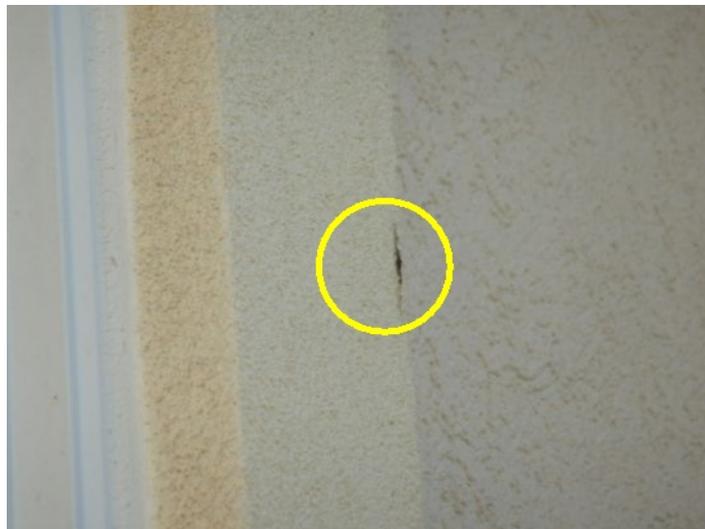
Page 11 Item: 2 | Rear of Home or Building

• Maintenance: Damaged area observed at the NW corner of the home. I suggest further evaluation by a licensed qualified **EFIS** contractor for repairs or replacement as needed.

Maintenance: Damaged area observed at the NW corner of the home.

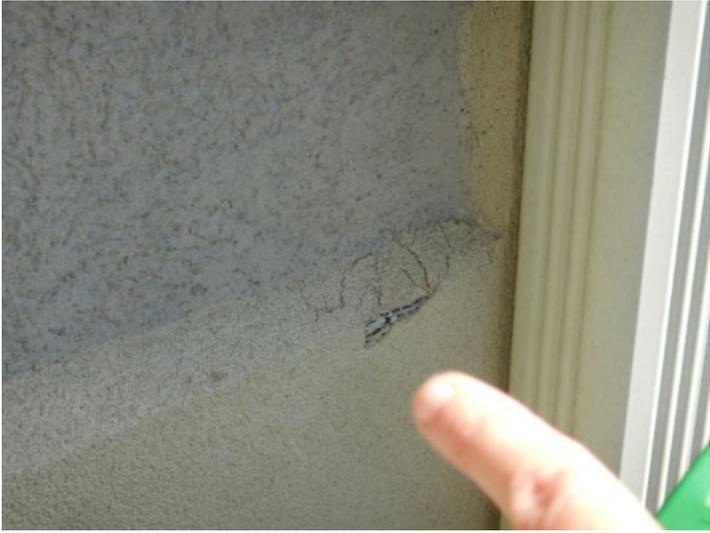
Page 13 Item: 3	South Side of Home or Building	<ul style="list-style-type: none"> <li>• Damaged areas at the bump out near the corner. I suggest further evaluation by a licensed qualified EIFS contractor for repairs or replacement as needed.</li> </ul>

<p style="text-align: center;">Damages observed</p>
Page 13 Item: 4	Exterior Cladding	<ul style="list-style-type: none"> <li>• Elevated moisture readings detected with a deep wall scanner at multiple areas. Problem areas were marked. Further intrusive probing revealed unremarkable moisture levels at depth. Pressure testing of the sheathing was normal at all locations. These findings indicate some moisture penetration is occurring at tested areas. However, it has not penetrated to the sheathing or caused damage to the sheathing. I suggest a full evaluation by an EIFS approved contractor for repairs and resealing as needed.</li> <li>• Damages and staining observed at a front column area. I suggest further evaluation by a licensed qualified EIFS contractor for repairs or replacement as needed.</li> <li>• The gutters around the front of the home have been fastened to or through the EIFS cladding. No sealant was visible in these areas. I suggest further evaluation by a qualified licensed EIFS contractor or gutter specialist for sealing and repairs as needed.</li> <li>• Cracked lamina and loose foam in contact with the driveway surfaces observed at the garage door trim areas. Moisture readings were unremarkable in these areas at the time of the inspection. The cladding is required to have an 8 inch clearance from the soil or hard surfaces. Have further evaluation by a qualified licensed EIFS contractor for repairs or replacement as needed.</li> </ul>

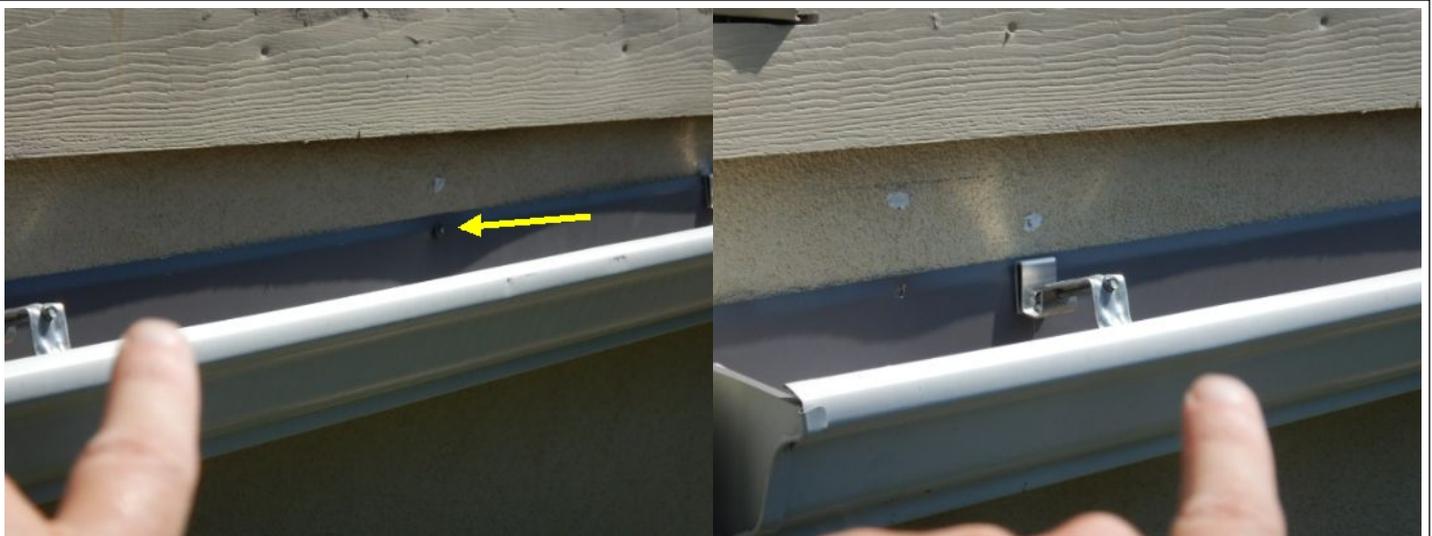
The gutters around the front of the home have been fastened to or through the EIFS cladding.

No visible sealant

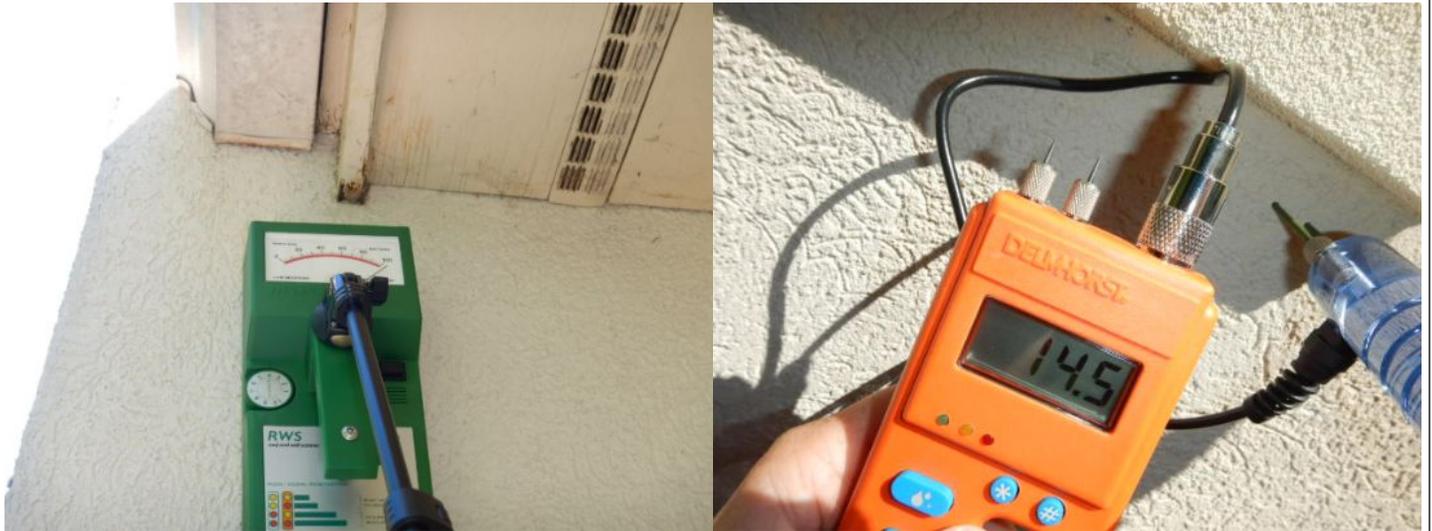
Higher moisture readings detected via wall scanner at multiple areas.

Intrusive moisture readings were unremarkable

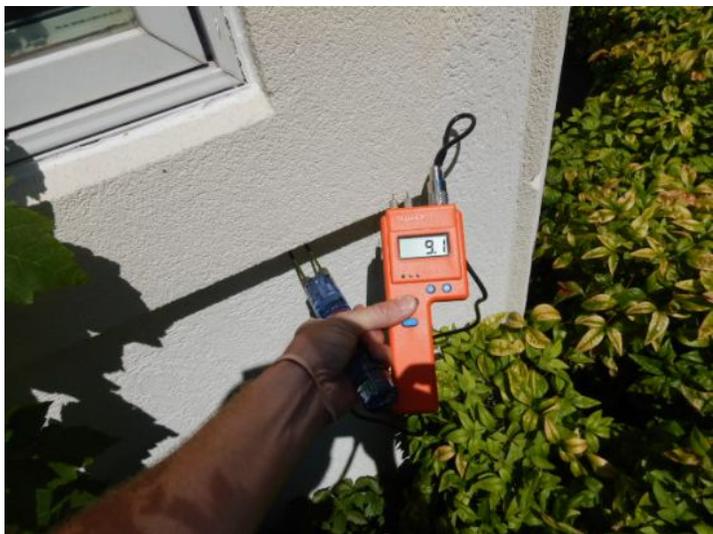
Further intrusive probing revealed unremarkable moisture levels at depth.

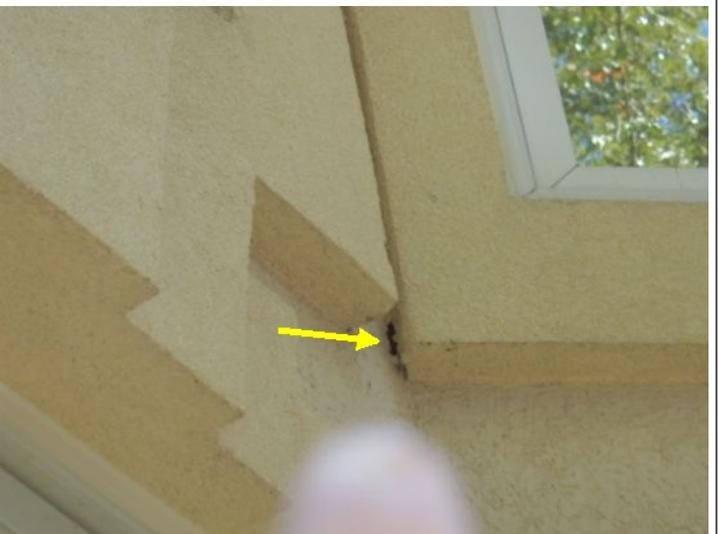
Crack observed

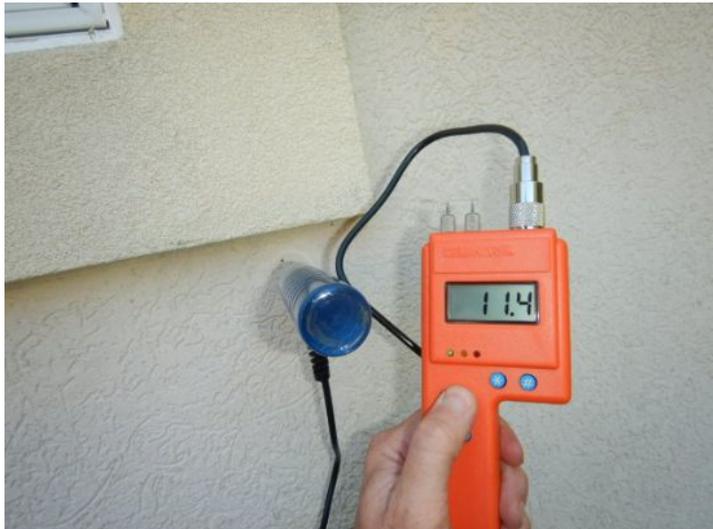
all deep probe readings were in the normal range and pressure test of the sheeting were also normal

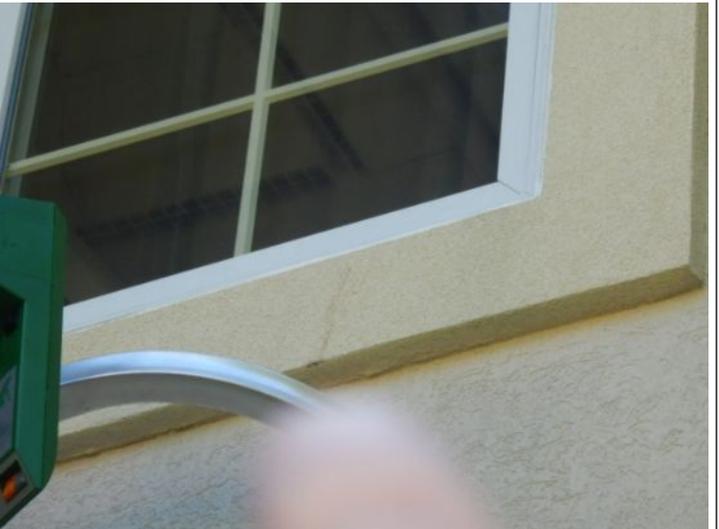
Crack observed

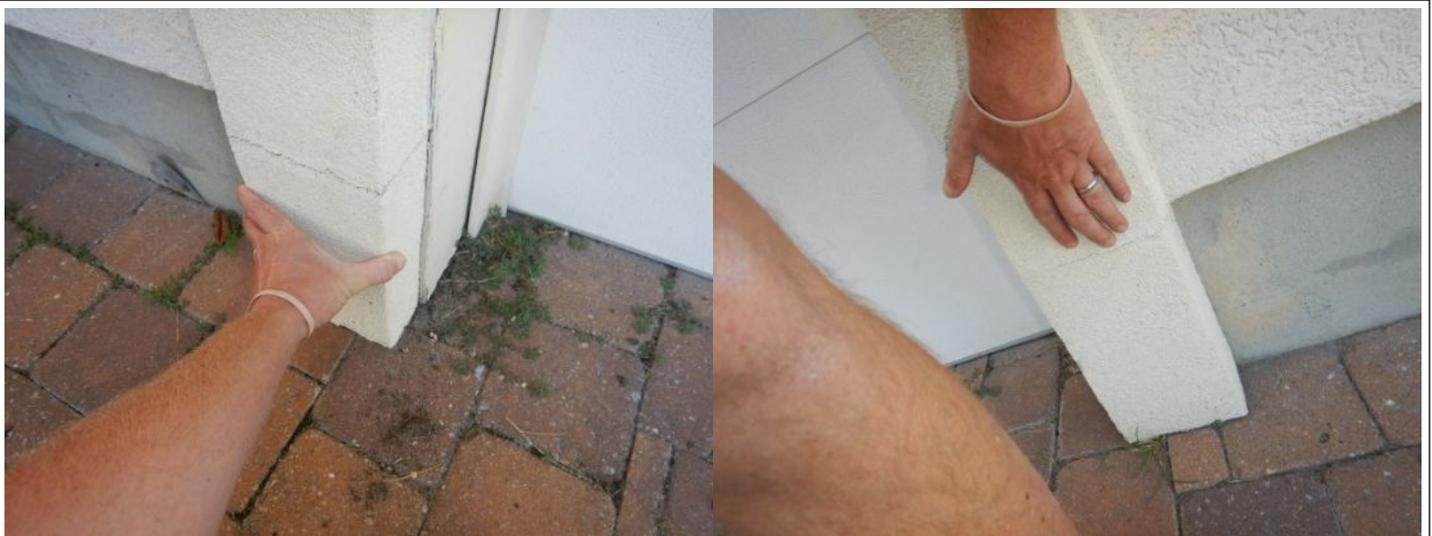
Cracked lamina and loose foam in contact with the driveway surfaces observed

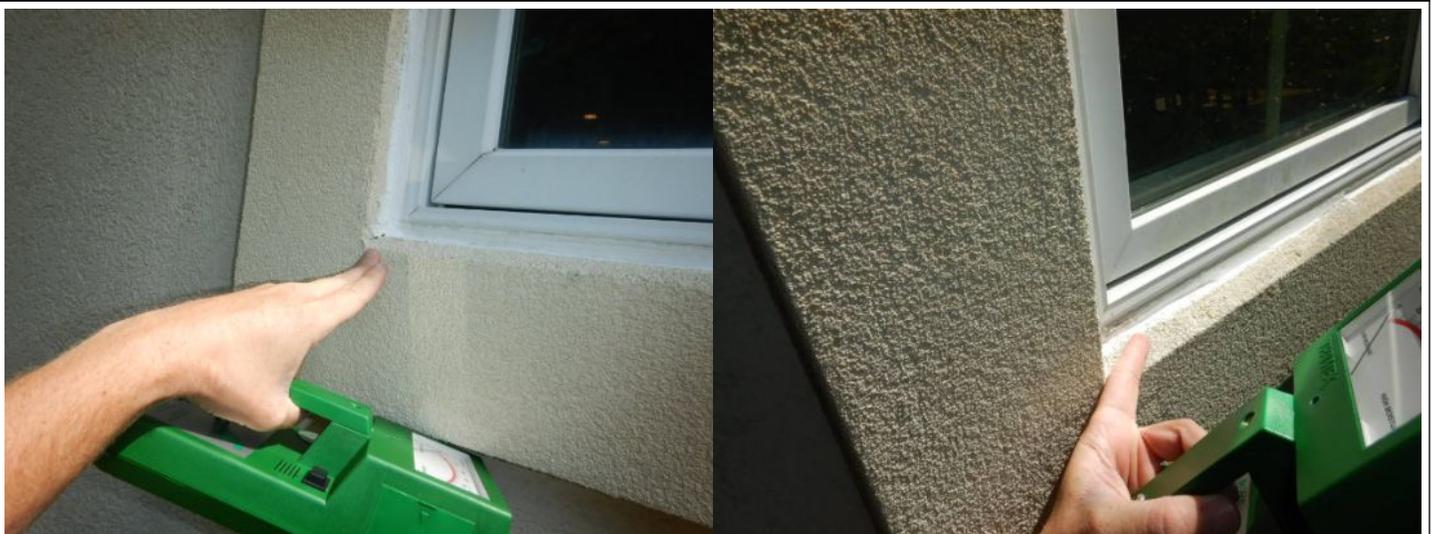
- Most windows around the home have caulking added around the perimeters. Some moisture was detected with a wall scanner at spots around and below some windows( probing revealed no elevated moisture at depth). Other exterior joints have also been caulked. Small gaps or areas with inconsistent installation ( missing new layer) were observed in the sealant at scattered locations. It is important that sealants be approved for EIFS. I am unable to determine if the previous or original sealant is approved for this application with EIFS material. I suggest further evaluation by qualified licensed EIFS contractor for repairs and re sealing with an approved for EIFS sealant at all locations as needed.

Poor sealant applications

Several windows around the home have inconsistent caulking around their perimeter.

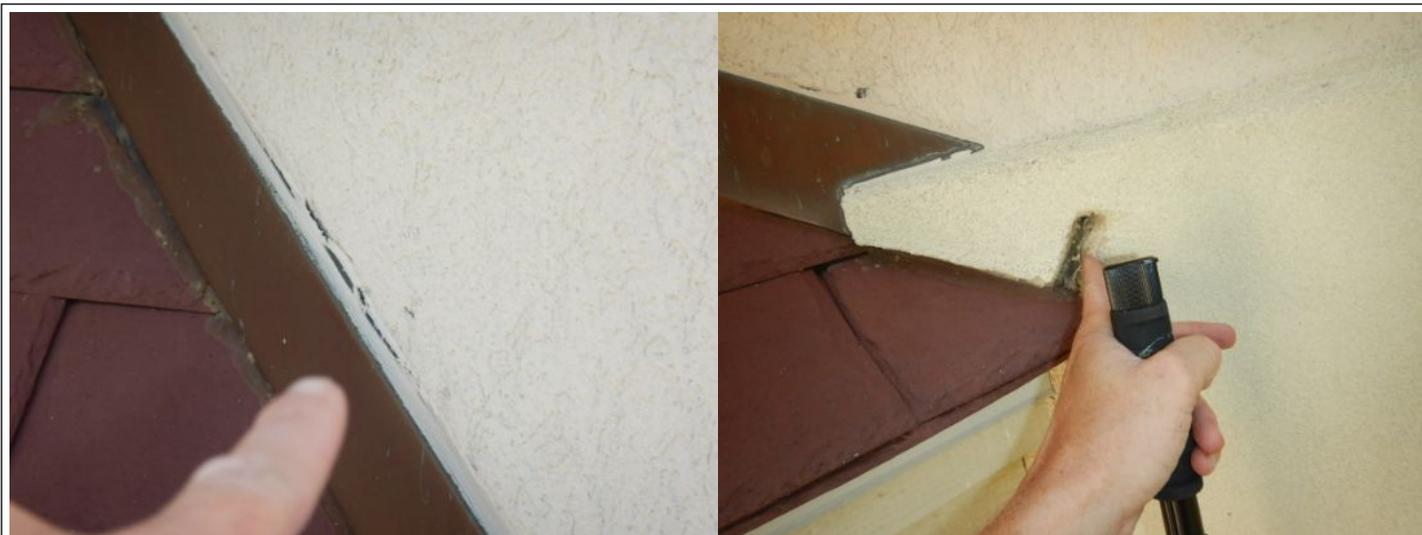
Cracked sealant

Cracked and damaged sealant observed

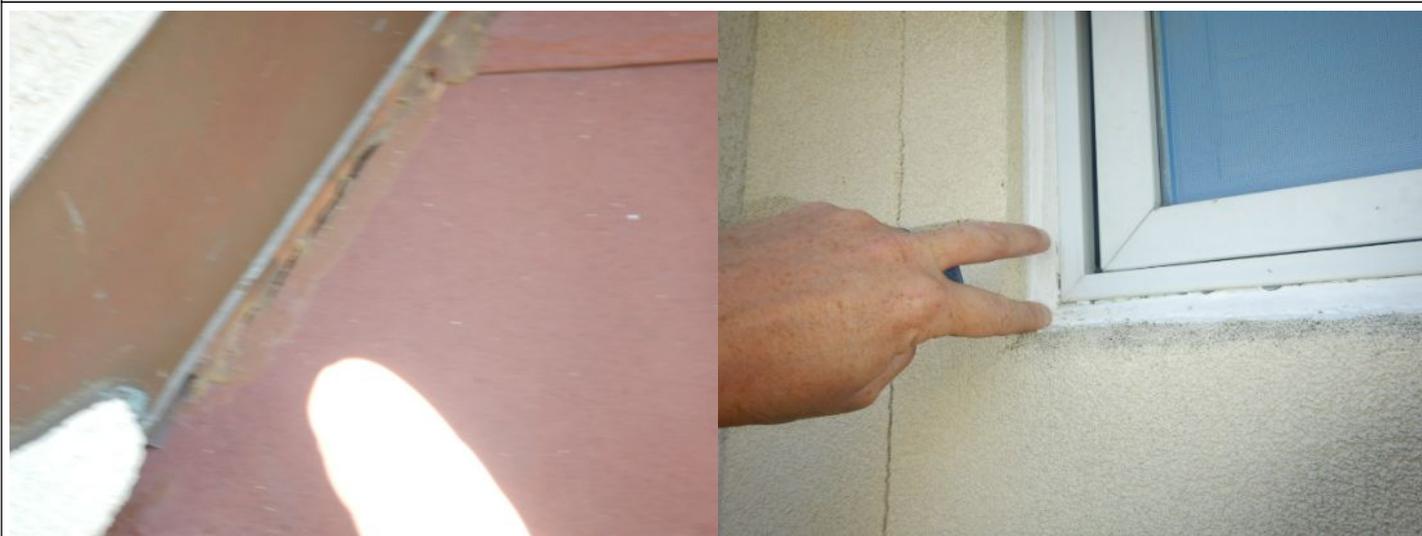
- Cracked and damaged sealant observed at the lower roof area at the rear of the home. Moisture readings were unremarkable in reachable areas. I suggest further evaluation by a licensed qualified EIFS contractor for repairs or sealing as needed.

Cracked and damaged sealant observed at the lower roof area at the rear of the home.

Several windows around the home have caulking issues

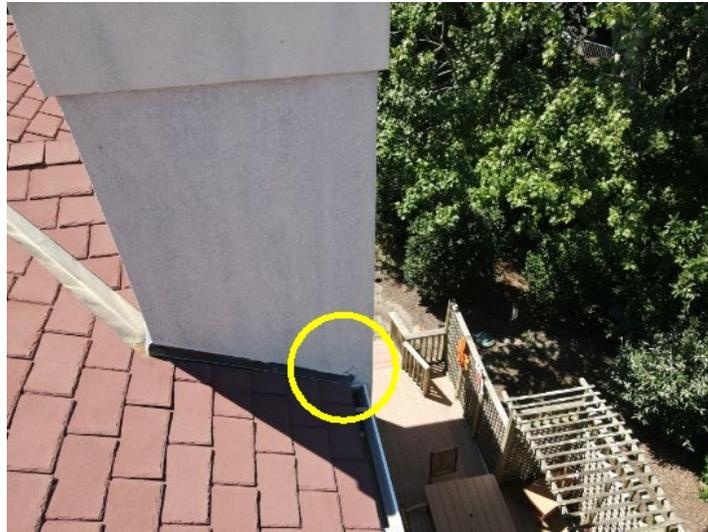
Page 22 Item: 2	Chimney(s)	<ul style="list-style-type: none"> <li>• Damages observed at a lower north corner of the rear, larger chimney. This area was accessed via drone. I could not determine if any hidden damages were present. I suggest further evaluation by a licensed qualified EIFS contractor for repairs or replacement as needed.</li> </ul>
-----------------	------------	--

Damages observed

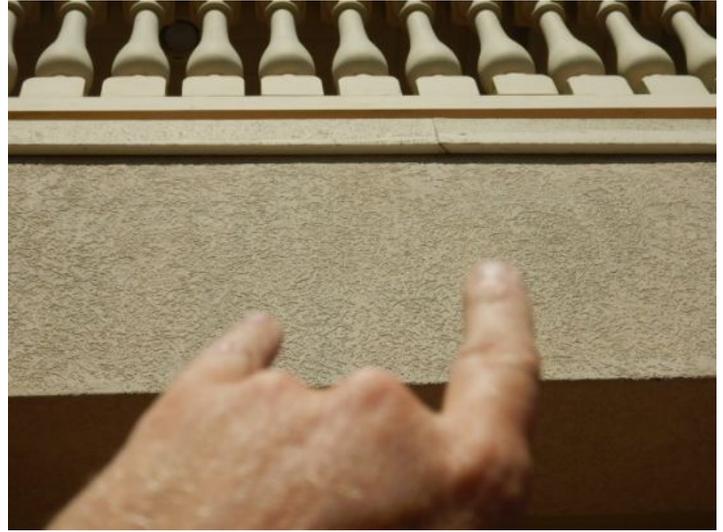
Balcony trim has been face nailed

- Maintenance: The trim around the lower perimeter of the front balcony appears to be face nailed to the EIFS cladding. I am unable to determine if these areas have been flashed or sealed properly. I suggest further evaluation by a licensed qualified EIFS contractor for sealing, repairs or replacement as needed.

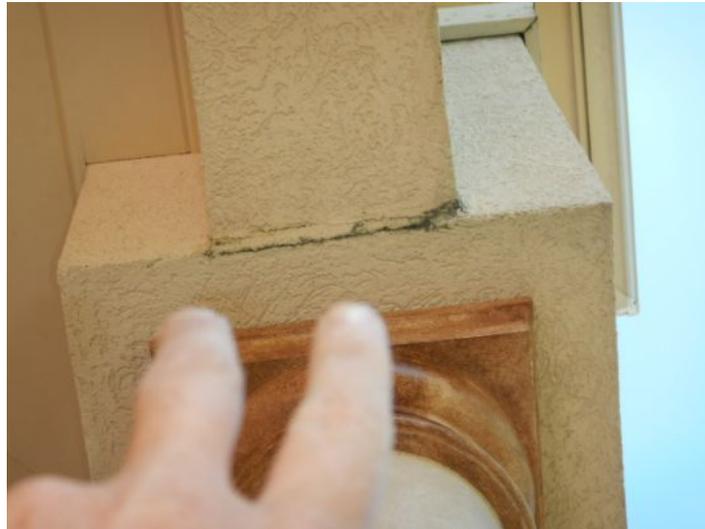
Damages and staining observed at a front column area.

- Damages and staining observed at a front column area. I suggest further evaluation by a licensed qualified EIFS contractor for repairs or replacement as needed.

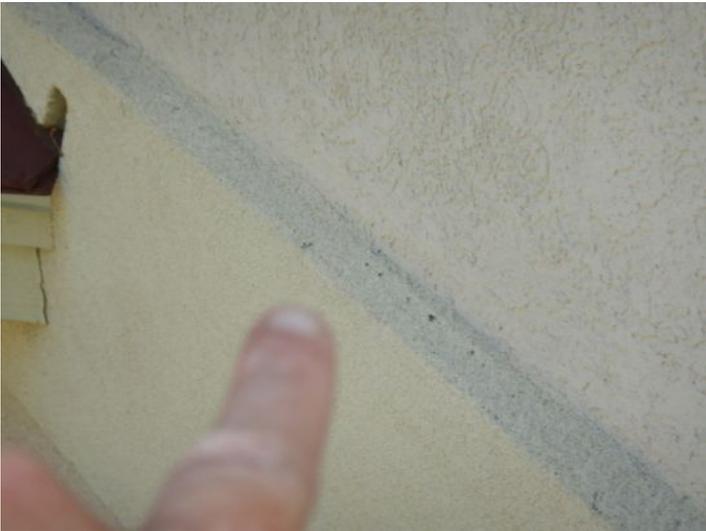
Maintenance: Chipped or thin lamina observed at scattered areas

- Maintenance: Chipped or thin lamina and damages observed at scattered areas of the home. I suggest further evaluation by a licensed qualified EIFS contractor for repairs or replacement as needed.

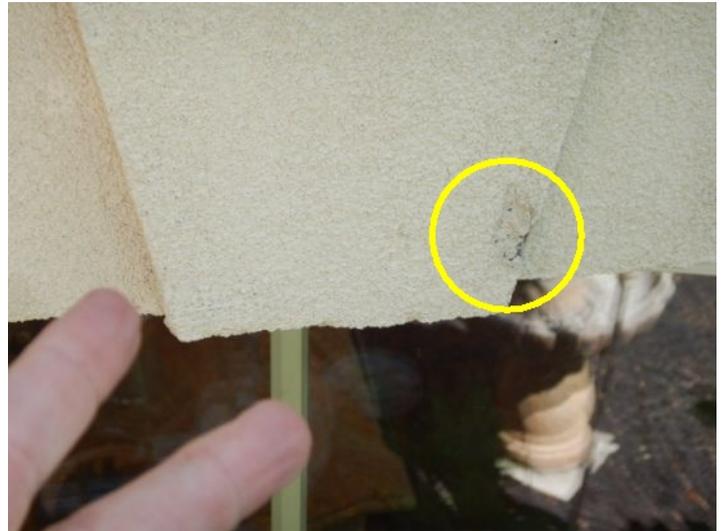
Maintenance: Mechanical or impact damages observed at scattered locations

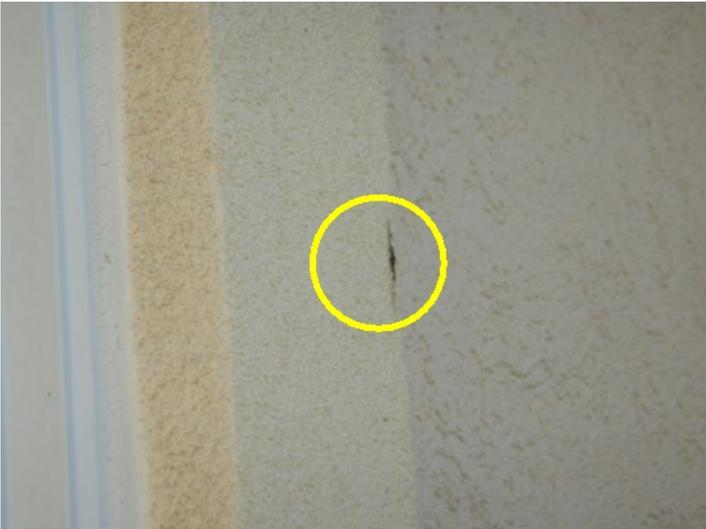
- Maintenance: Damaged area observed at the NW corner of the home. I suggest further evaluation by a licensed qualified EIFS contractor for repairs or replacement as needed.

Maintenance: Damaged area observed at the NW corner of the home.

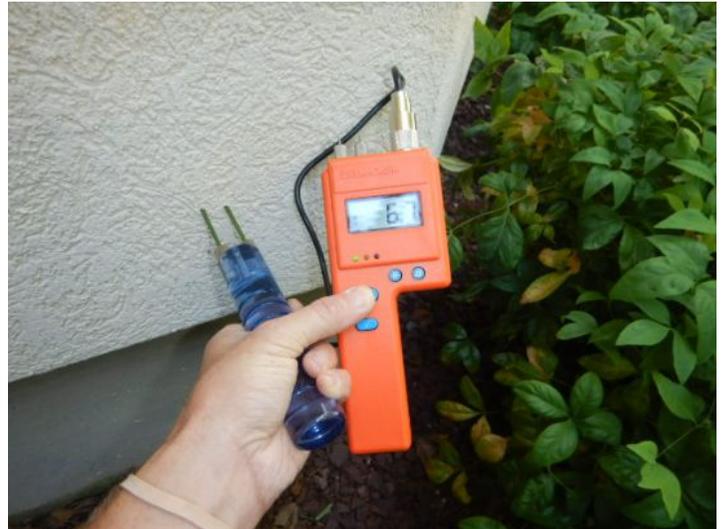
Intrusive probing revealed unremarkable moisture levels.

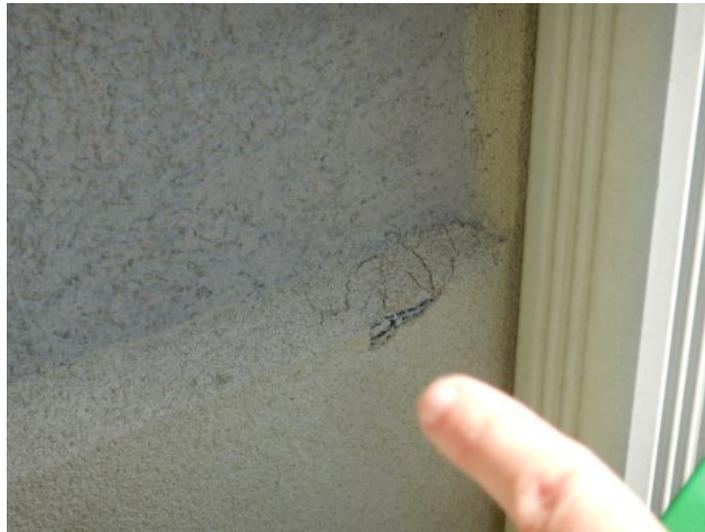
- Damaged areas at the bump out near the corner. I suggest further evaluation by a licensed qualified EIFS contractor for repairs or replacement as needed.

Damages observed

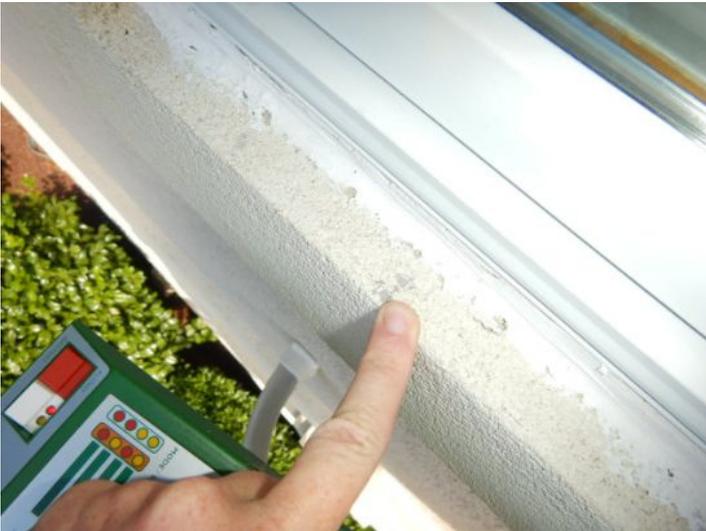
Thin or chipped lamina

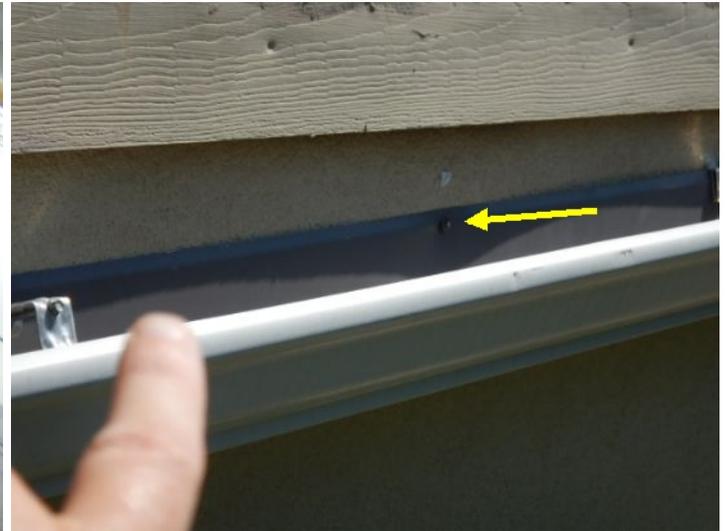
- The gutters around the front of the home have been fastened to or through the EIFS cladding. No sealant was visible in these areas. I suggest further evaluation by a qualified licensed EIFS contractor or gutter specialist for sealing and repairs as needed.

The gutters around the front of the home have been fastened to or through the EIFS cladding.

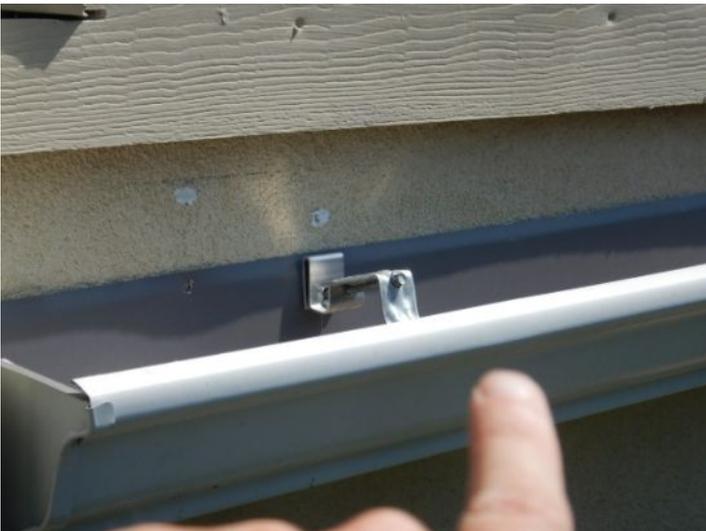
No visible sealant

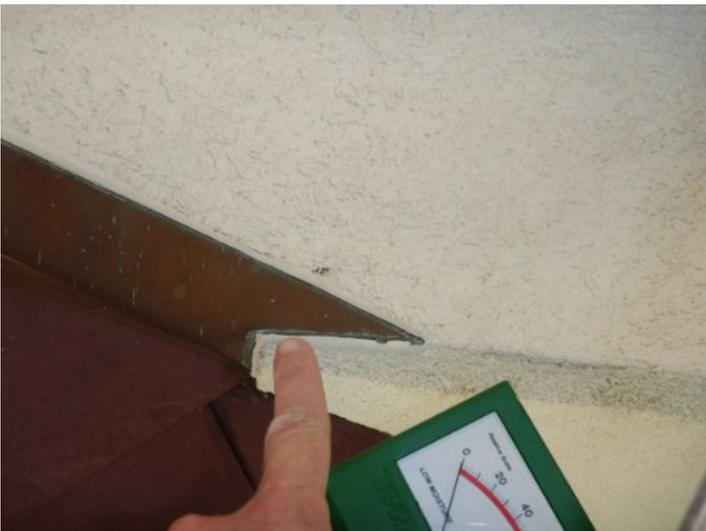
- Maintenance: EIFS does not have the recommended 2 inch clearance from the roof covering at the lower corners of the rear, lower roof area. I suggest further evaluation by a licensed qualified EIFS contractor for repairs or sealing in these areas as needed.

EIFS does not have the recommended 2 inch clearance from the roof covering at all areas.

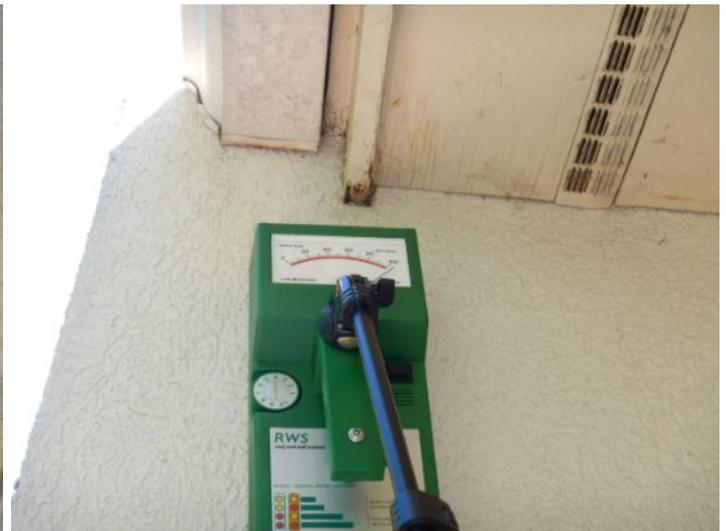
- Elevated moisture readings detected with a deep wall scanner at multiple areas. Problem areas were marked. Further intrusive probing revealed unremarkable moisture levels at depth. Pressure testing of the sheathing was normal at all locations. These findings indicate some moisture penetration is occurring at tested areas. However, it has not penetrated to the sheathing or caused damage to the sheathing. I suggest a full evaluation by an EIFS approved contractor for repairs and resealing as needed.

Higher moisture readings detected via wall scanner at multiple areas.

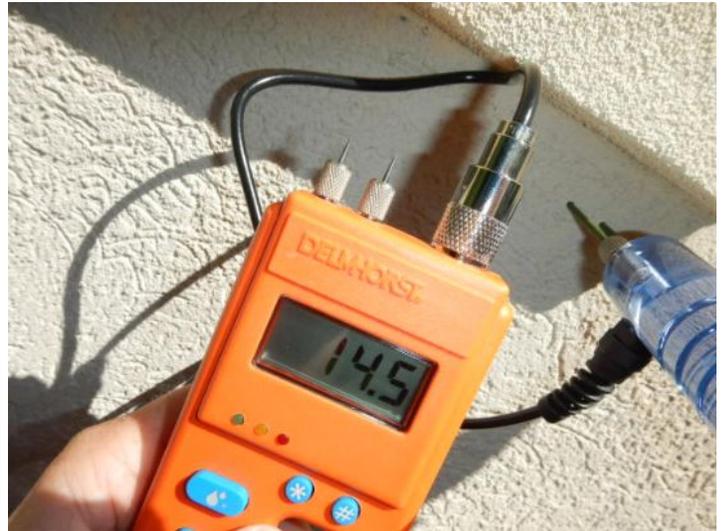
Intrusive moisture readings were unremarkable

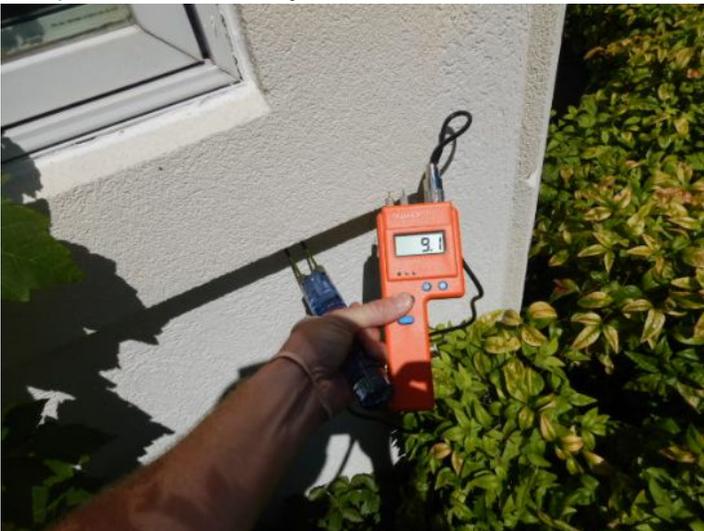
Further intrusive probing revealed unremarkable moisture levels at depth.

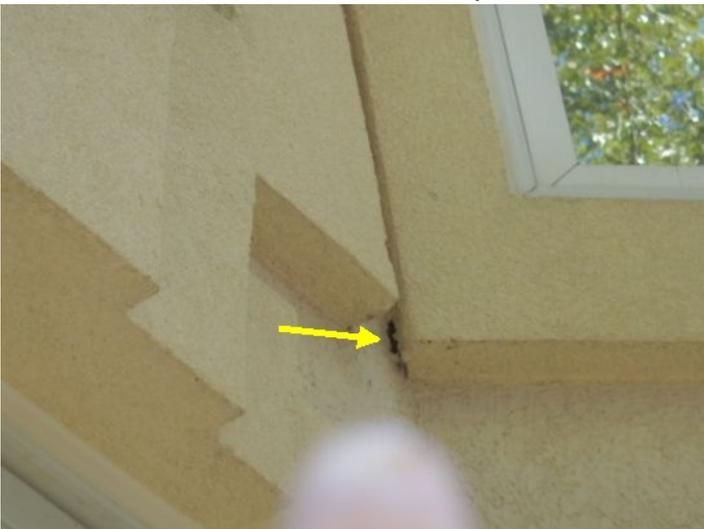
Crack observed

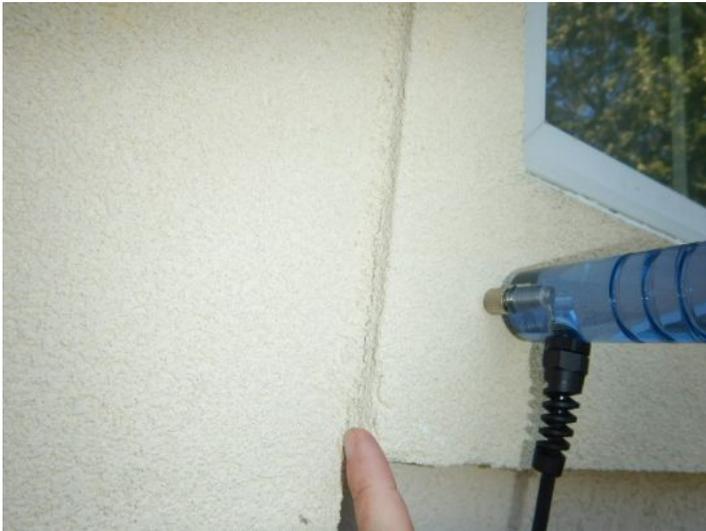
Small areas of damages observed at scattered spots

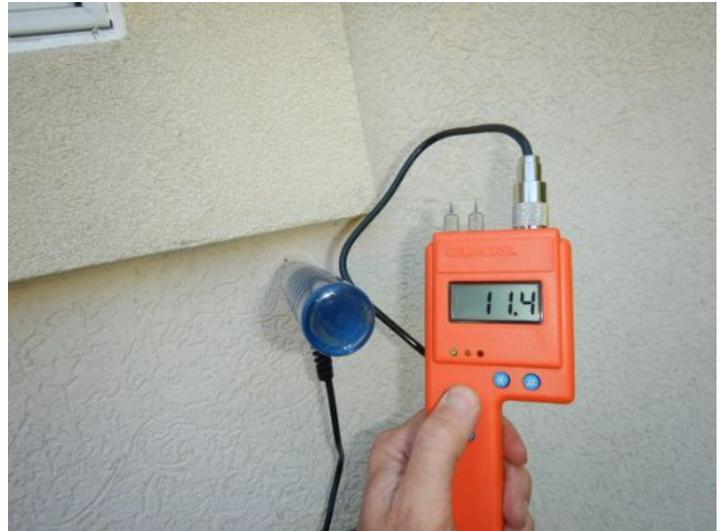
all deep probe readings were in the normal range and pressure test of the sheeting were also normal

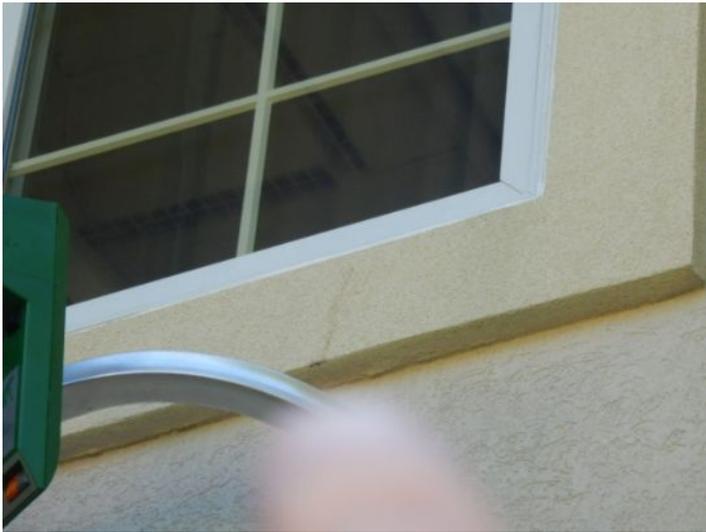
Crack observed

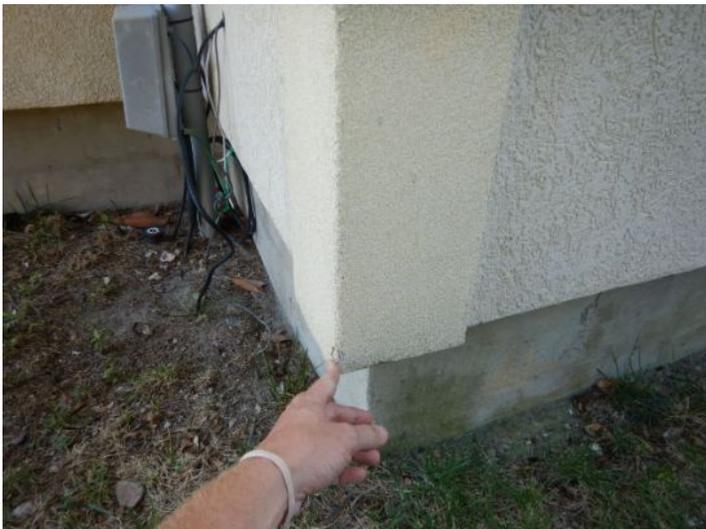
Small areas of damages observed at scattered locations.

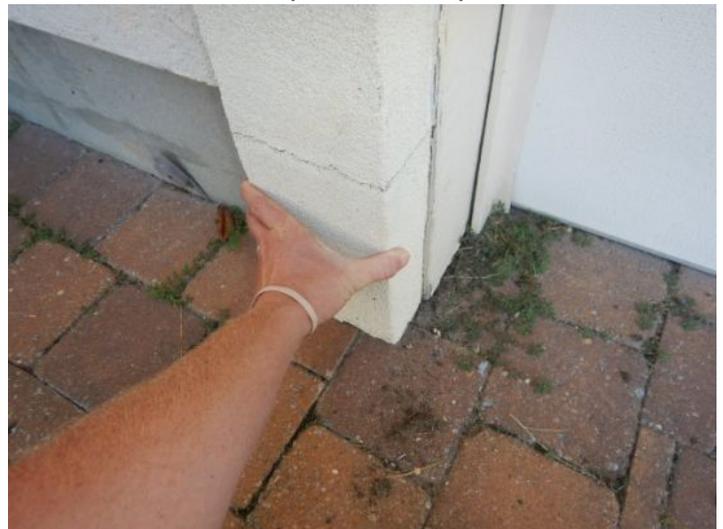
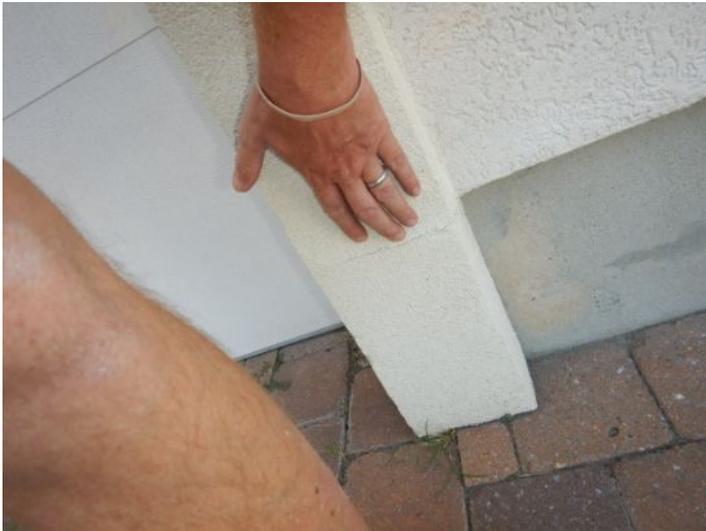
- Cracked lamina and loose foam in contact with the driveway surfaces observed at the garage door trim areas. Moisture readings were unremarkable in these areas at the time of the inspection. The cladding is required to have an 8 inch clearance from the soil or hard surfaces. Have further evaluation by a qualified licensed EIFS contractor for repairs or replacement as needed.

Cracked lamina and loose foam in contact with the driveway surfaces observed

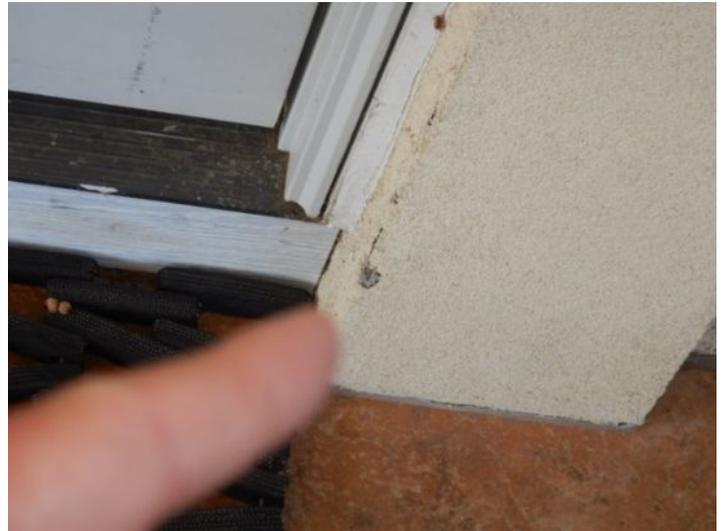
Small areas of damage observed

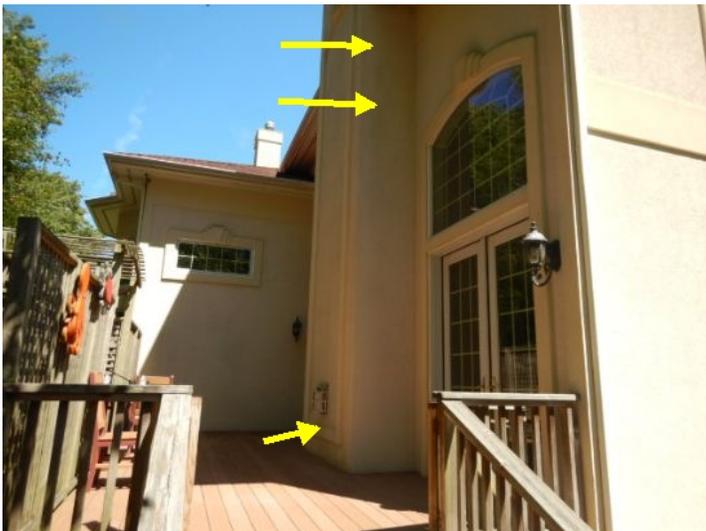
- Maintenance: The siding needs a good cleaning in some areas. Algae staining observed. I suggest having cleaned as needed.
- Maintenance: There are several spots where the mulch, dirt or gravel is at or close to the EIFS cladding at the rear of the home. I suggest further evaluation by a licensed contractor for adjusting the grade as needed.

Maintenance: The siding needs a good cleaning in some areas. Algae staining observed.

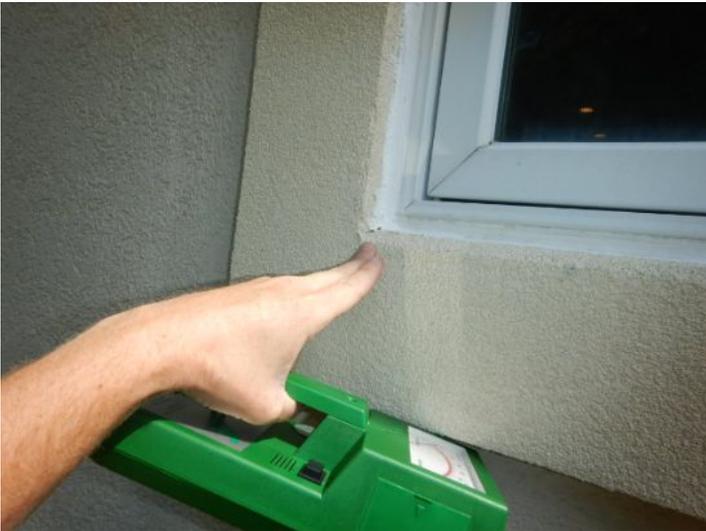
- **NOTE: USE CAULK APPROVED FOR EIFS.**
- Most windows around the home have caulking added around the perimeters. Some moisture was detected with a wall scanner at spots around and below some windows( probing revealed no elevated moisture at depth). Other exterior joints have also been caulked. Small gaps or areas with inconsistent installation ( missing new layer) were observed in the sealant at scattered locations. It is important that sealants be approved for EIFS. I am unable to determine if the previous or original sealant is approved for this application with EIFS material. I suggest further evaluation by qualified licensed EIFS contractor for repairs and re sealing with an approved for EIFS sealant at all locations as needed.

Poor sealant applications

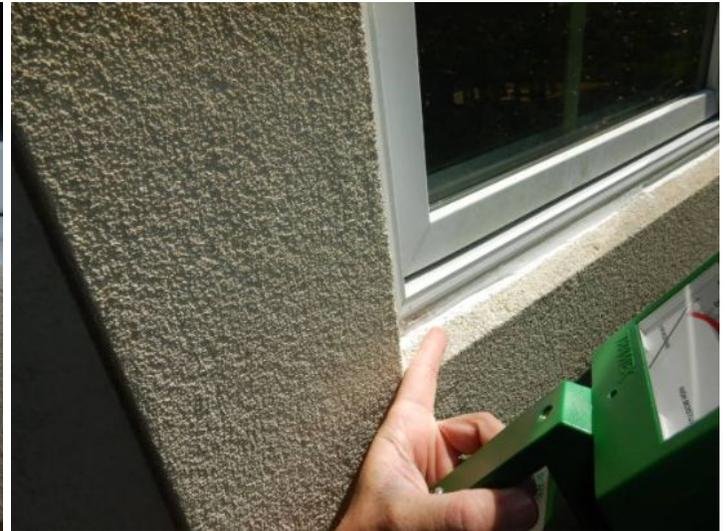
Several windows around the home have inconsistent caulking around their perimeter.

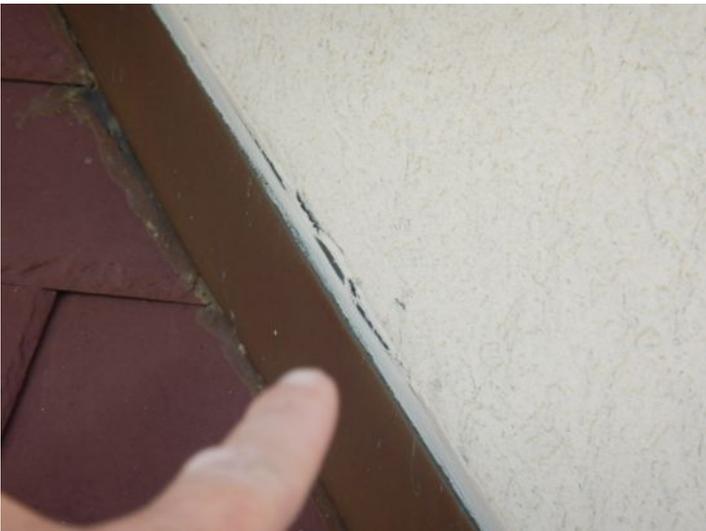
Cracked sealant

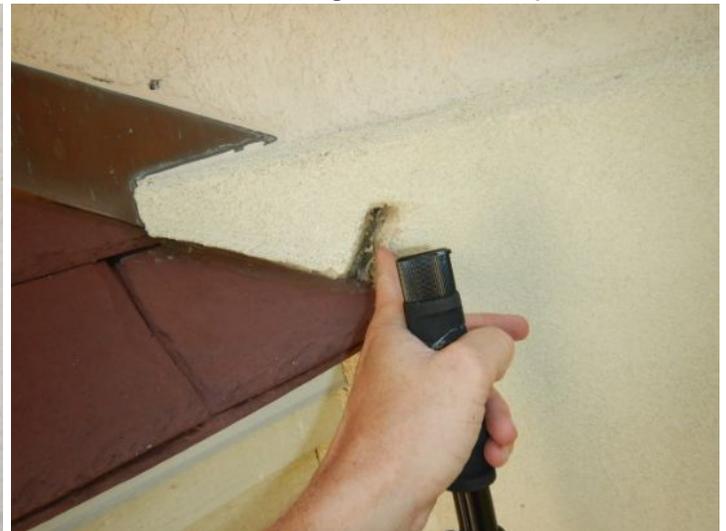
Cracked and damaged sealant observed

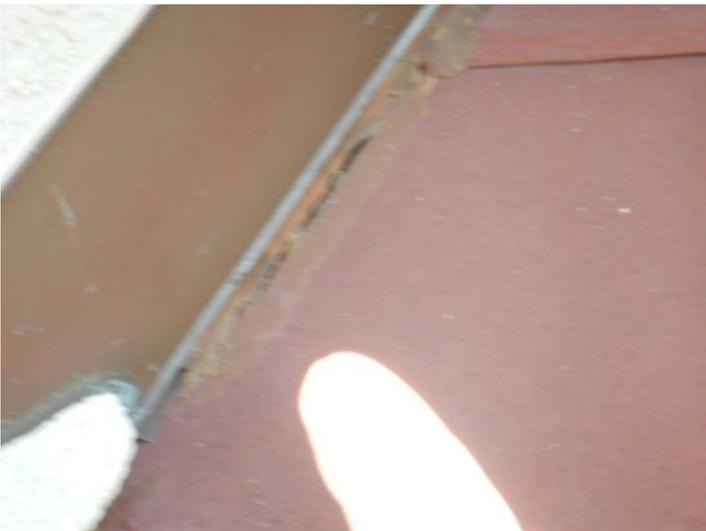
- Cracked and damaged sealant observed at the lower roof area at the rear of the home. Moisture readings were unremarkable in reachable areas. I suggest further evaluation by a licensed qualified EIFS contractor for repairs or sealing as needed.

Cracked and damaged sealant observed at the lower roof area at the rear of the home.

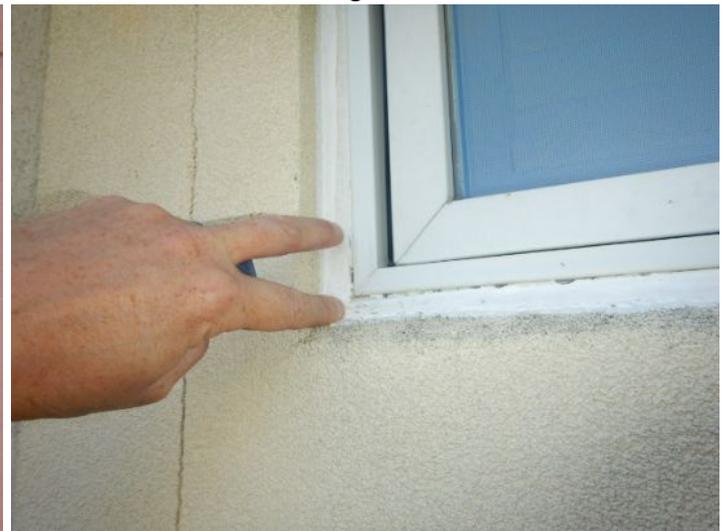
Several windows around the home have caulking issues

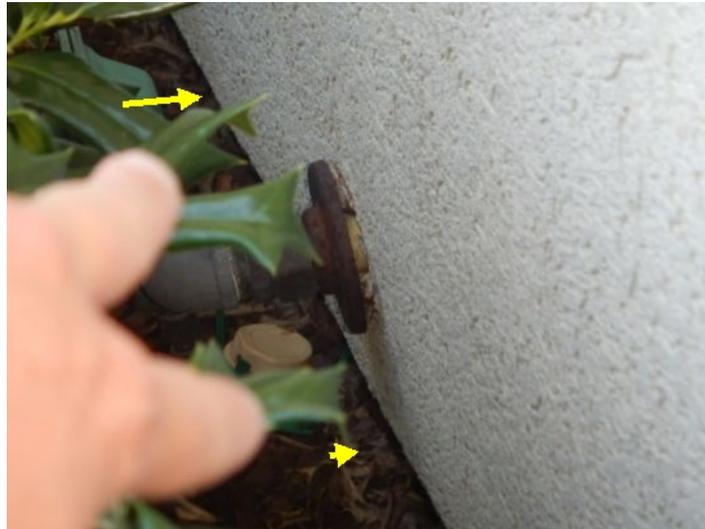
- Maintenance: There are several spots where the mulch/dirt/gravel is at or close to the EIFS cladding at the rear of the home. I suggest further evaluation by a licensed contractor for adjusting the grade as needed.

Maintenance: There are several spots where the mulch/dirt/gravel is at or close to the EIFS cladding at the rear of the home. Sealing needed at the hose bib

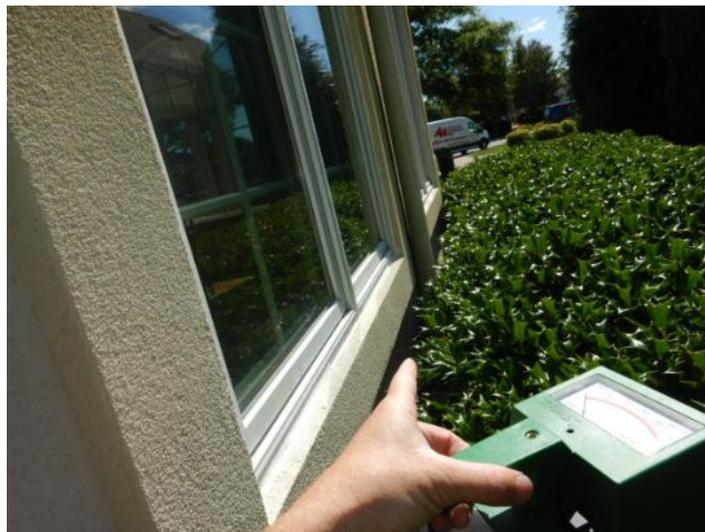
Maintenance: Overgrown vegetation in contact with structure. Trim/prune/remove as needed at all locations.

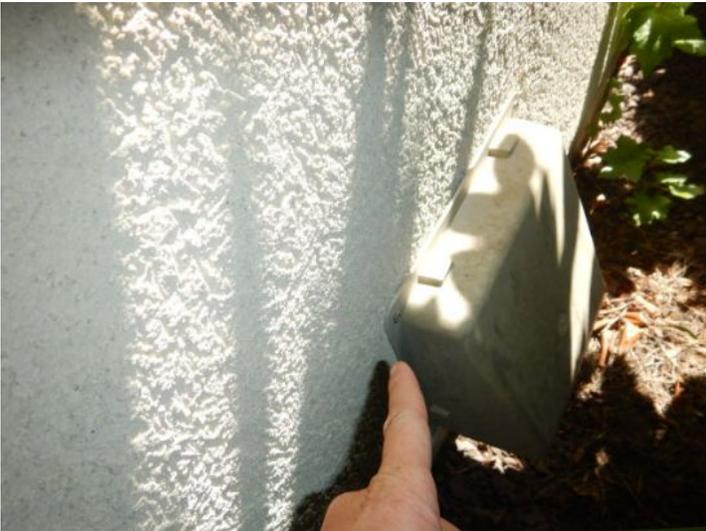
- Maintenance: Penetrations(i.e. light fixtures, pipes, vents) should have sealant to prevent moisture penetration and subsequent damages. Moisture readings at or around penetrations or fixtures were unremarkable at the time of the inspection. I suggest having these areas sealed as needed.

Sealant needed

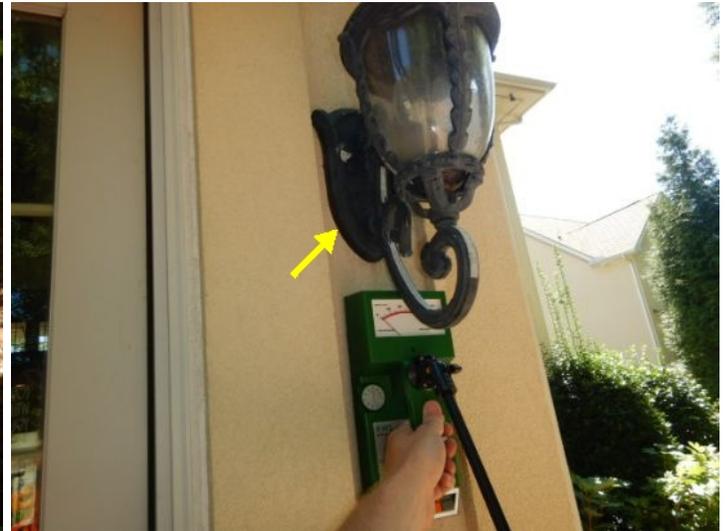
No sealant at fixture
