# Exterior Cladding Inspection Report

Bay Farm Rd., Long Neck , DE 19966

Date of Inspection: 5/10/2022

Inspector: Jake Raynor

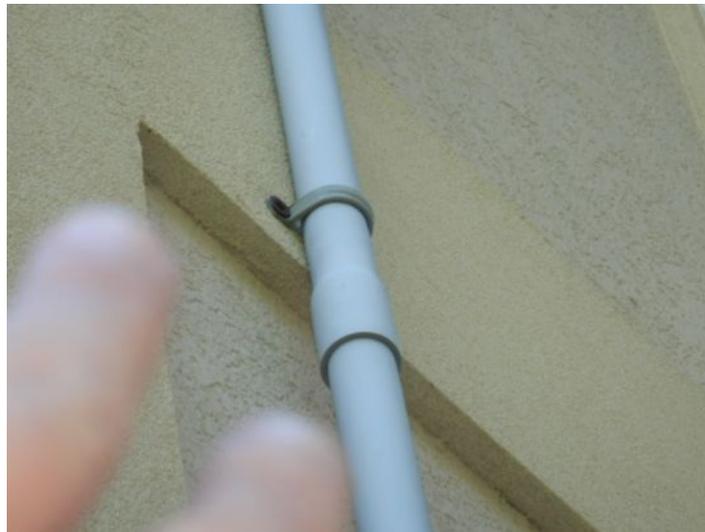
Maintenance: Penetrations(i.e. light fixtures, pipes, vents) should have sealant

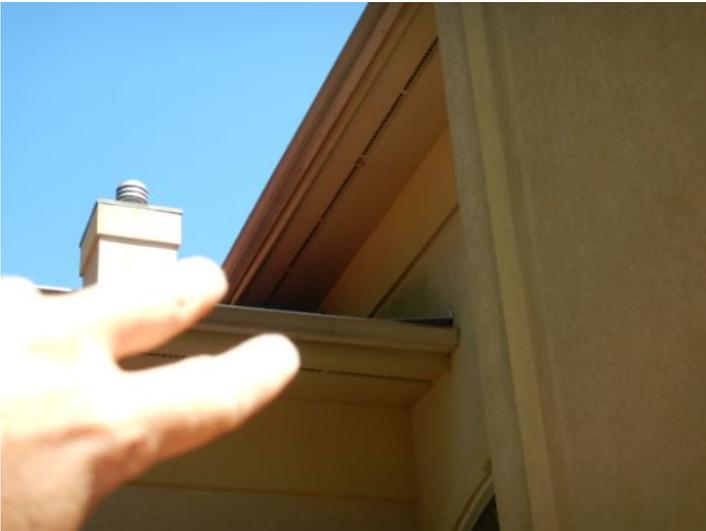
- Maintenance: Kick out flashing not present at several areas of the roof. This style flashing should be installed to prevent possible moisture intrusion and damages. I suggest further evaluation by a licensed roofer or qualified EIFS contractor for installation and improvement as needed.

Kick out flashing not present at several areas of the roof.

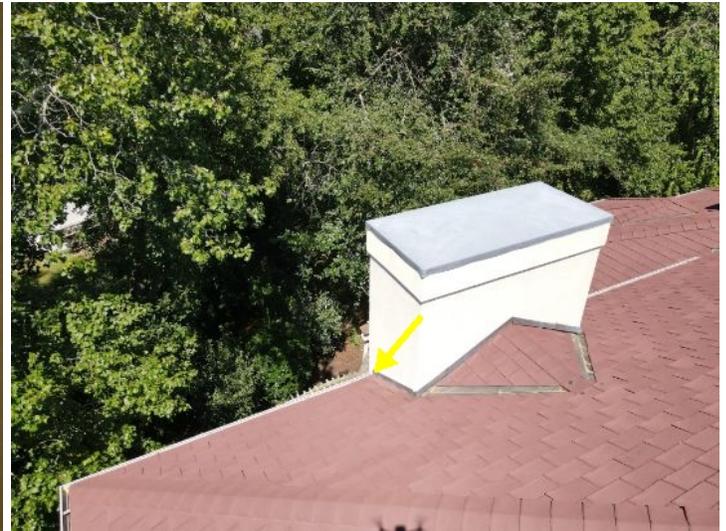
Kick out flashing needed

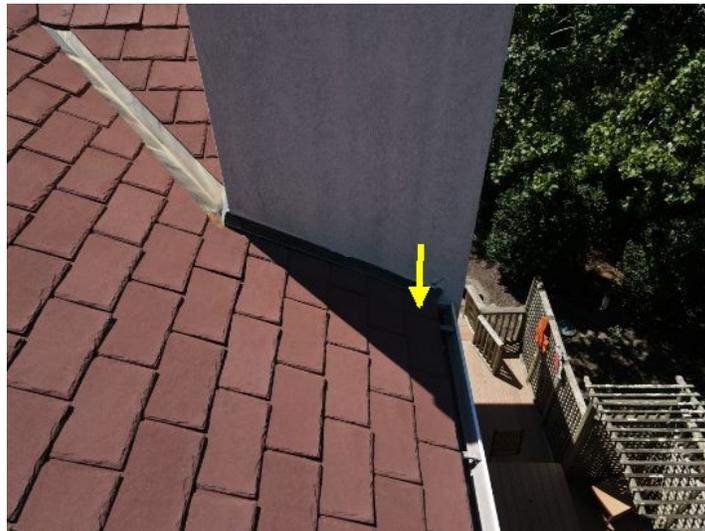
Kick out flashing needed

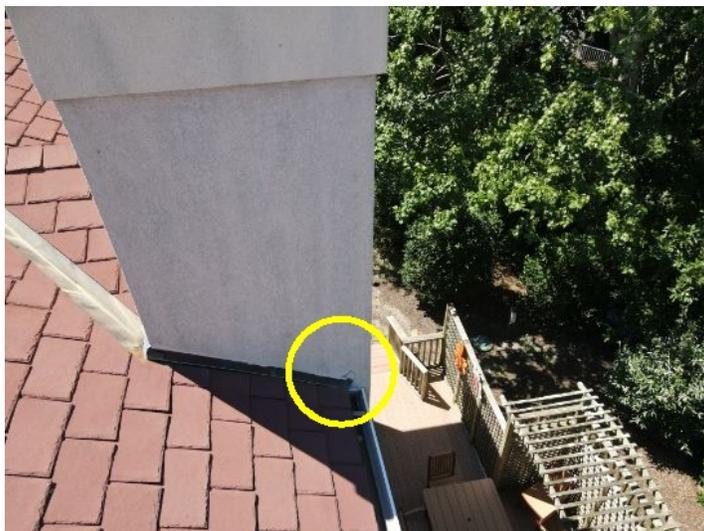
- Damages observed at a lower north corner of the rear, larger chimney. This area was accessed via drone. I could not determine if any hidden damages were present. I suggest further evaluation by a licensed qualified EIFS contractor for repairs or replacement as needed.

Damages observed

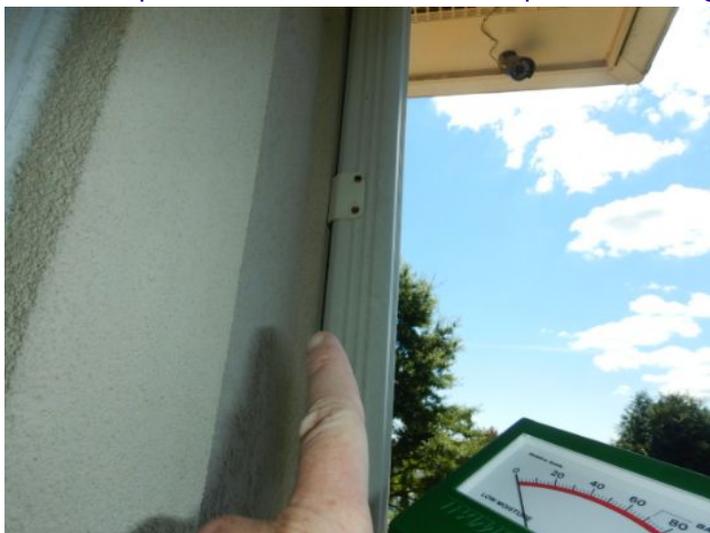
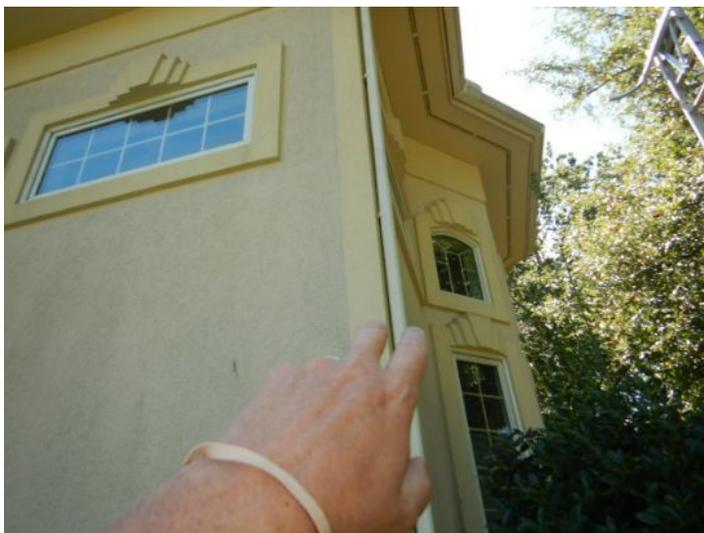
- Maintenance: Downspout brackets have not been properly sealed. I suggest further evaluation by a licensed qualified EIFS contractor for repairs or sealing as needed.

Maintenance: Downspout brackets have not been properly sealed.
