Residential Inspection Report

1234 Sample Report Dr, Eastern Shore, MD DE VA 12345

Date of Inspection: 11/1/2019 Time: 9:00 am

Manufactured Home Sample Report

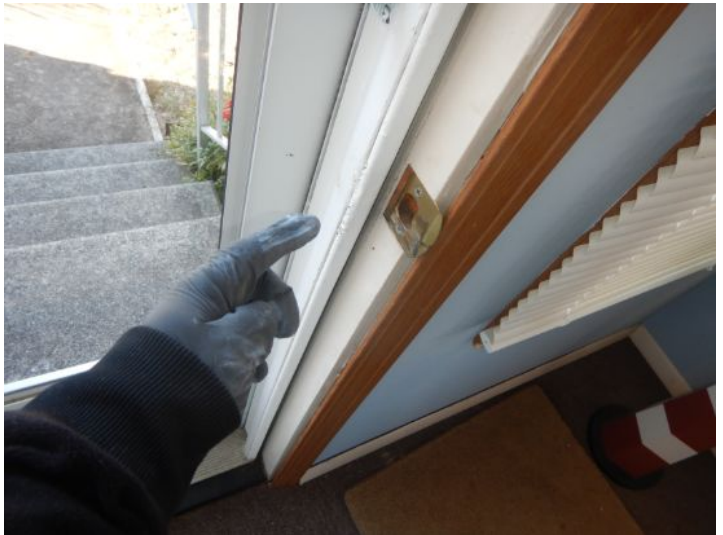
- Maintenance: Shut the front door with caution as your fingers can get pinch due to the trim that was installed. I suggest removal of this trim as needed.
- Sliding glass door does not open/close properly. Its takes a lot of effort to slide. I suggest further evaluation by a licensed contractor for repair or replacement as needed.
- Cloudiness / condensation observed at the rear glass slider . Left un repaired, over time moisture damage could occur to surrounding areas. I suggest having further evaluation by a licensed window specialist for repair or replacement as needed.

Maintenance: Shut the front door with caution as your fingers can get pinch due to the trim that was installed

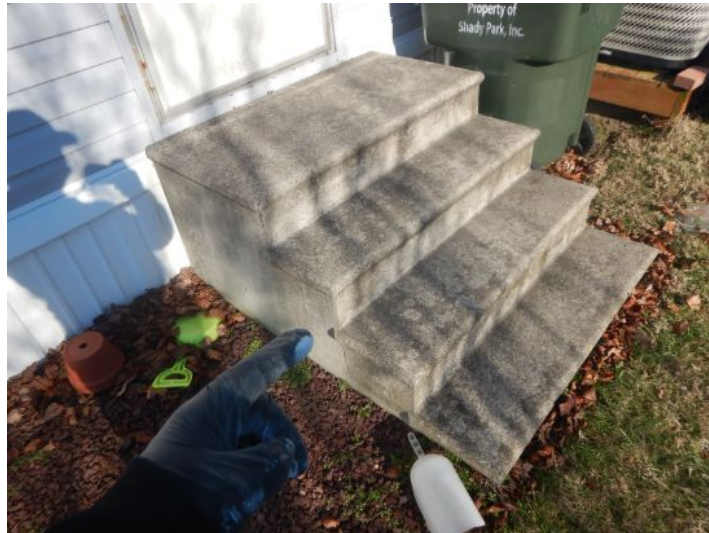
- Maintenance: There were no hand rails installed at the south side steps. Install as desired for increased safety.

Maintenance: There were no hand rails installed

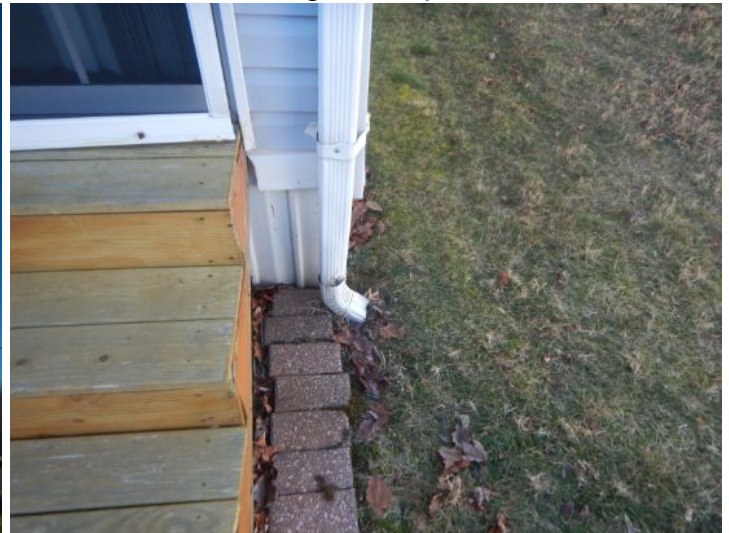
Maintenance: Splash blocks needed in several locations and/or need some adjustments

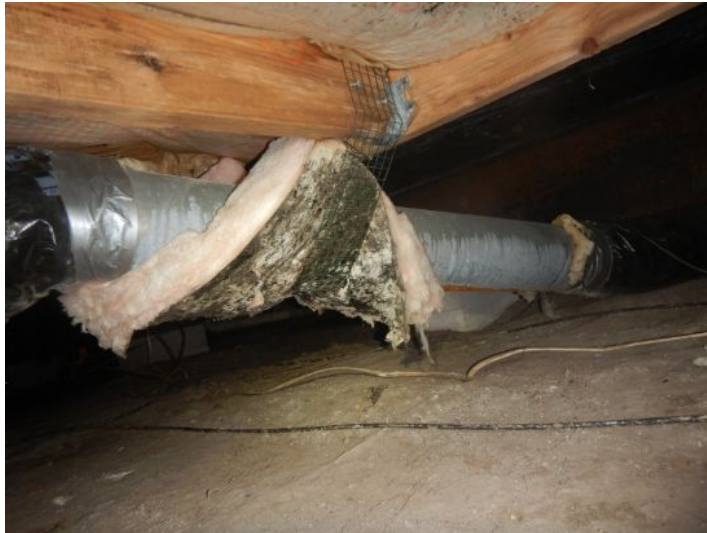
- Annual/Seasonal professional HVAC inspection and cleaning service contract is recommended.
- Maintenance: Damaged/missing insulation observed on one flex line under the addition. Have a licensed HVAC contractor make repairs or replacements as needed.

Maintenance: Damaged/missing insulation observed

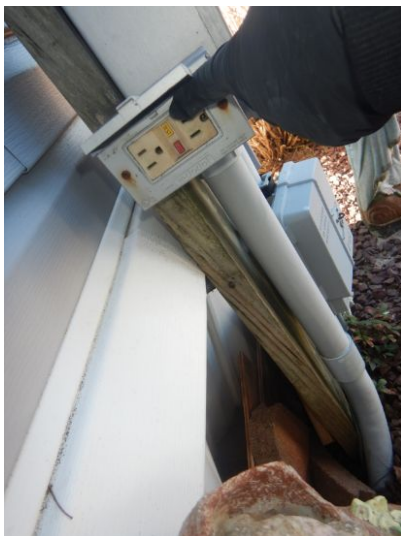
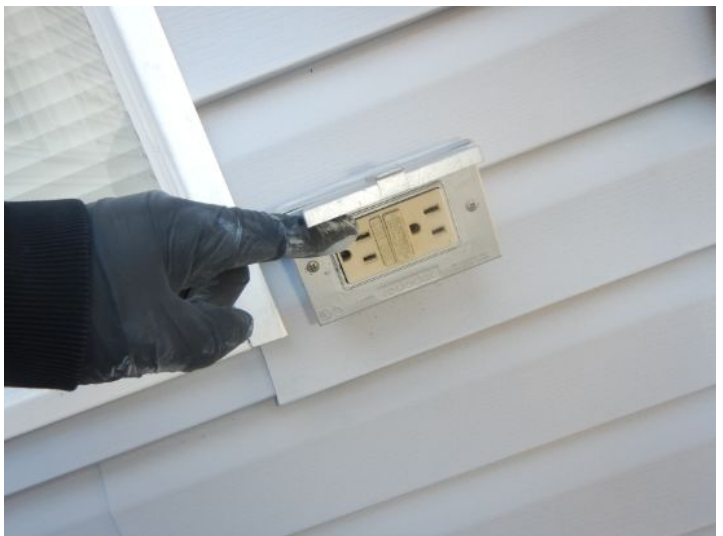
- Test GFCIs monthly to ensure proper operation.
- Maintenance: There is no GFCI protection in the kitchen. I recommend having a licensed electrician install GFCI'S as needed for increased safety.
- GFCI(s) did not work properly at both exterior outlets. I suggest further evaluation by a licensed electrical contractor for repair or replacement as needed.

GFCI(s) did not work properly

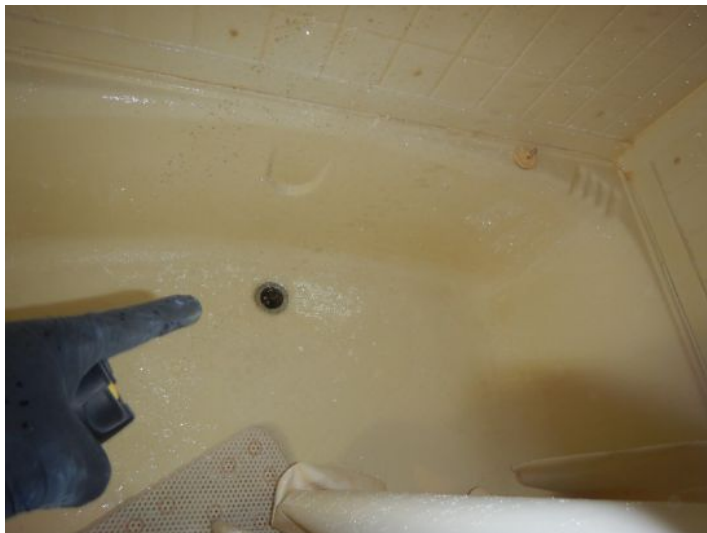
- Maintenance: Stopper is not installed and or plastic/rubber stopper is in use. Have a licensed plumber install or replace as needed.

Maintenance: Stopper is not installed

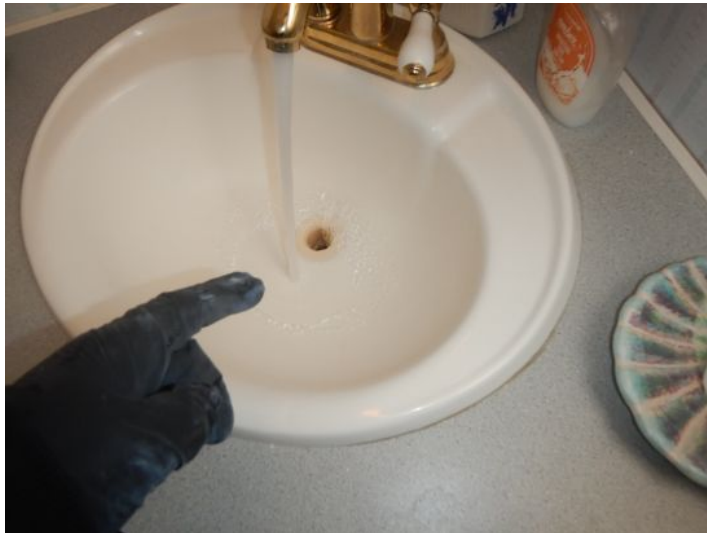
- Maintenance: Missing stoppers observed at both bathroom sinks. I suggest further evaluation by a licensed plumber for repair or replacement as needed.

Maintenance: Missing stoppers observed

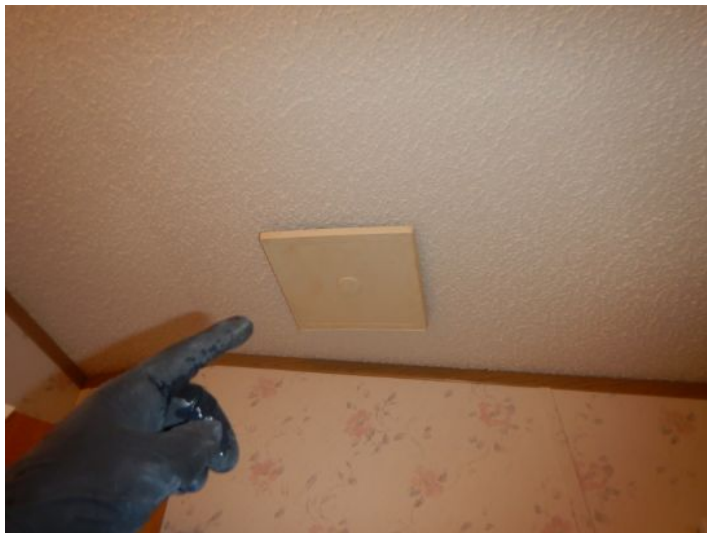
- Maintenance: Bathroom exhaust fan operated but was noisy in the rear bathroom. Repair or replace as needed/desired.

Maintenance: Bathroom exhaust fan operated but was noisy

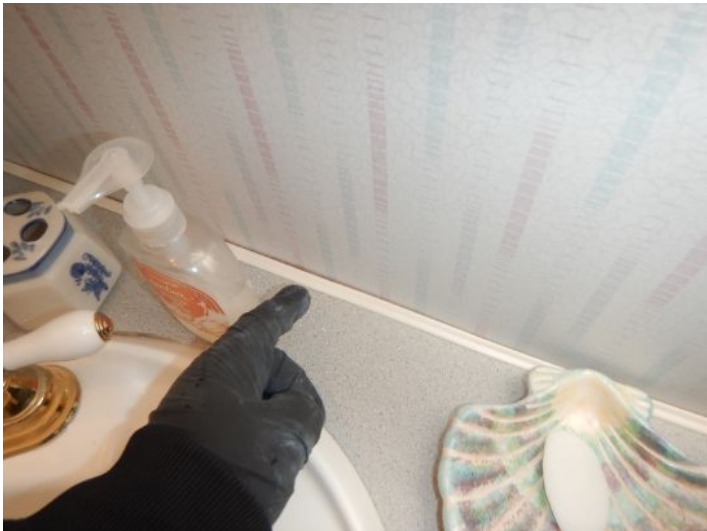
Maintenance: Caulking suggested at the perimeter of the vanity counter top and back splash.

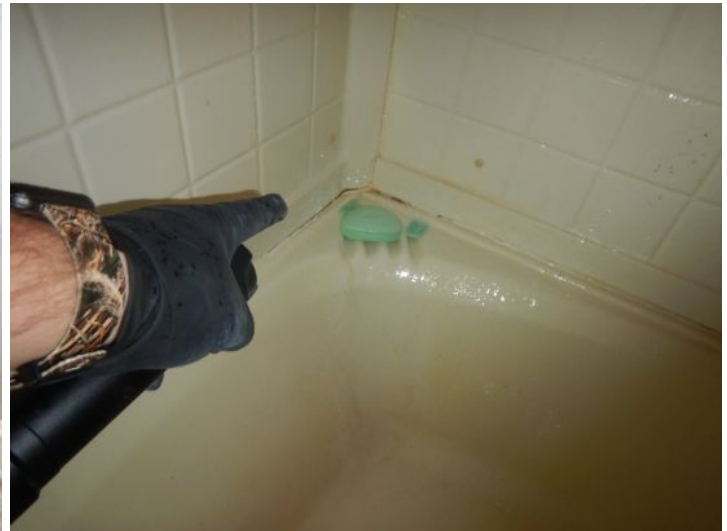
Maintenance: Some re caulking needed at the bath and shower areas.

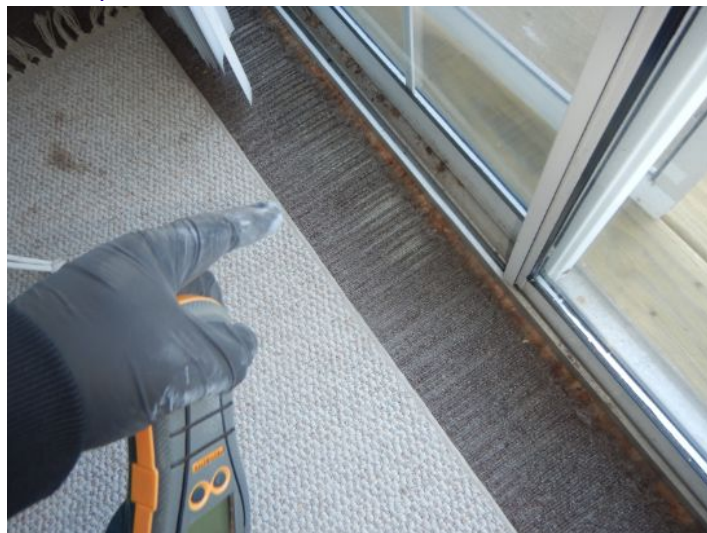
- Maintenance: Heavy wear, staining and damages at scattered locations. Have further evaluation by a flooring specialist for repairs or replacement as needed

Maintenance: Heavy wear, staining and damages

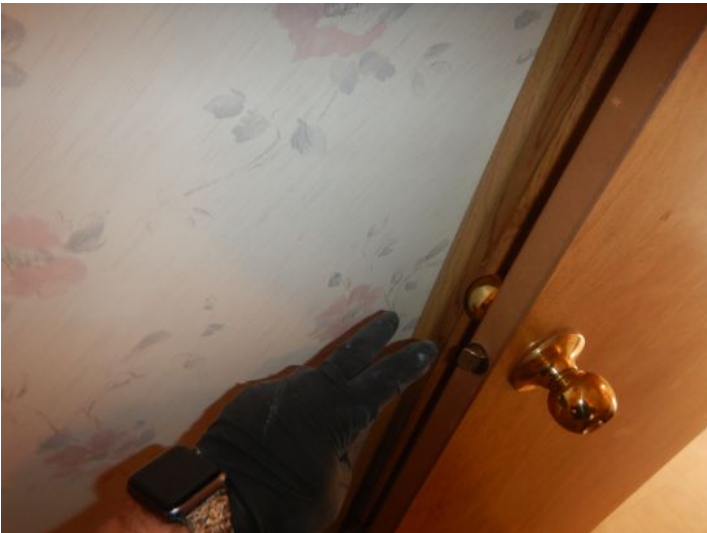
Maintenance: The door stops are either damaged or missing

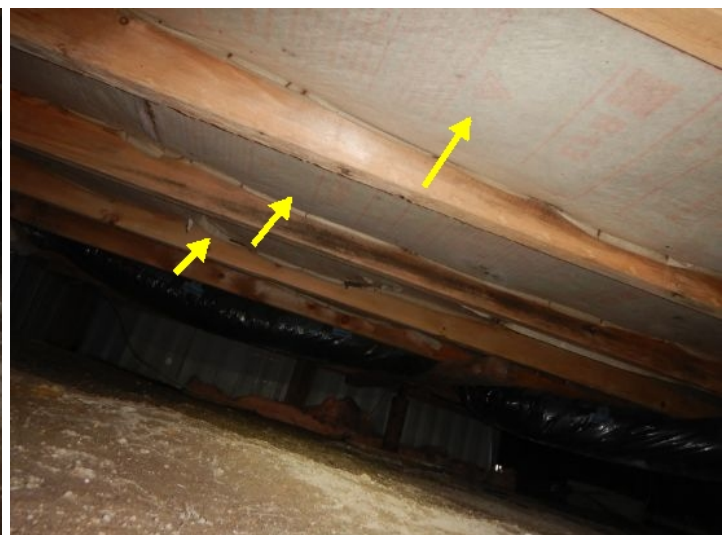
FYI: The insulation in the crawl space is installed upside down

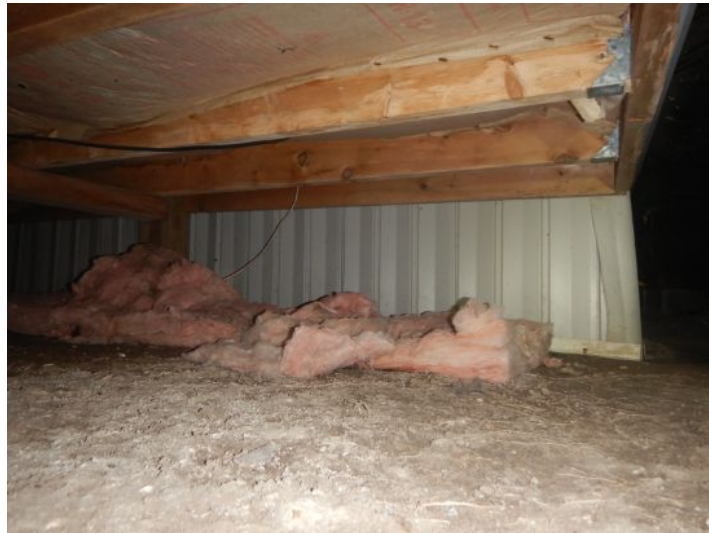
Maintenance: Section of insulation has fallen down
